Dropped load – water

Safety Flash Published on 28 May 2019 Generated on 28 January 2026 IMCA SF 12/19

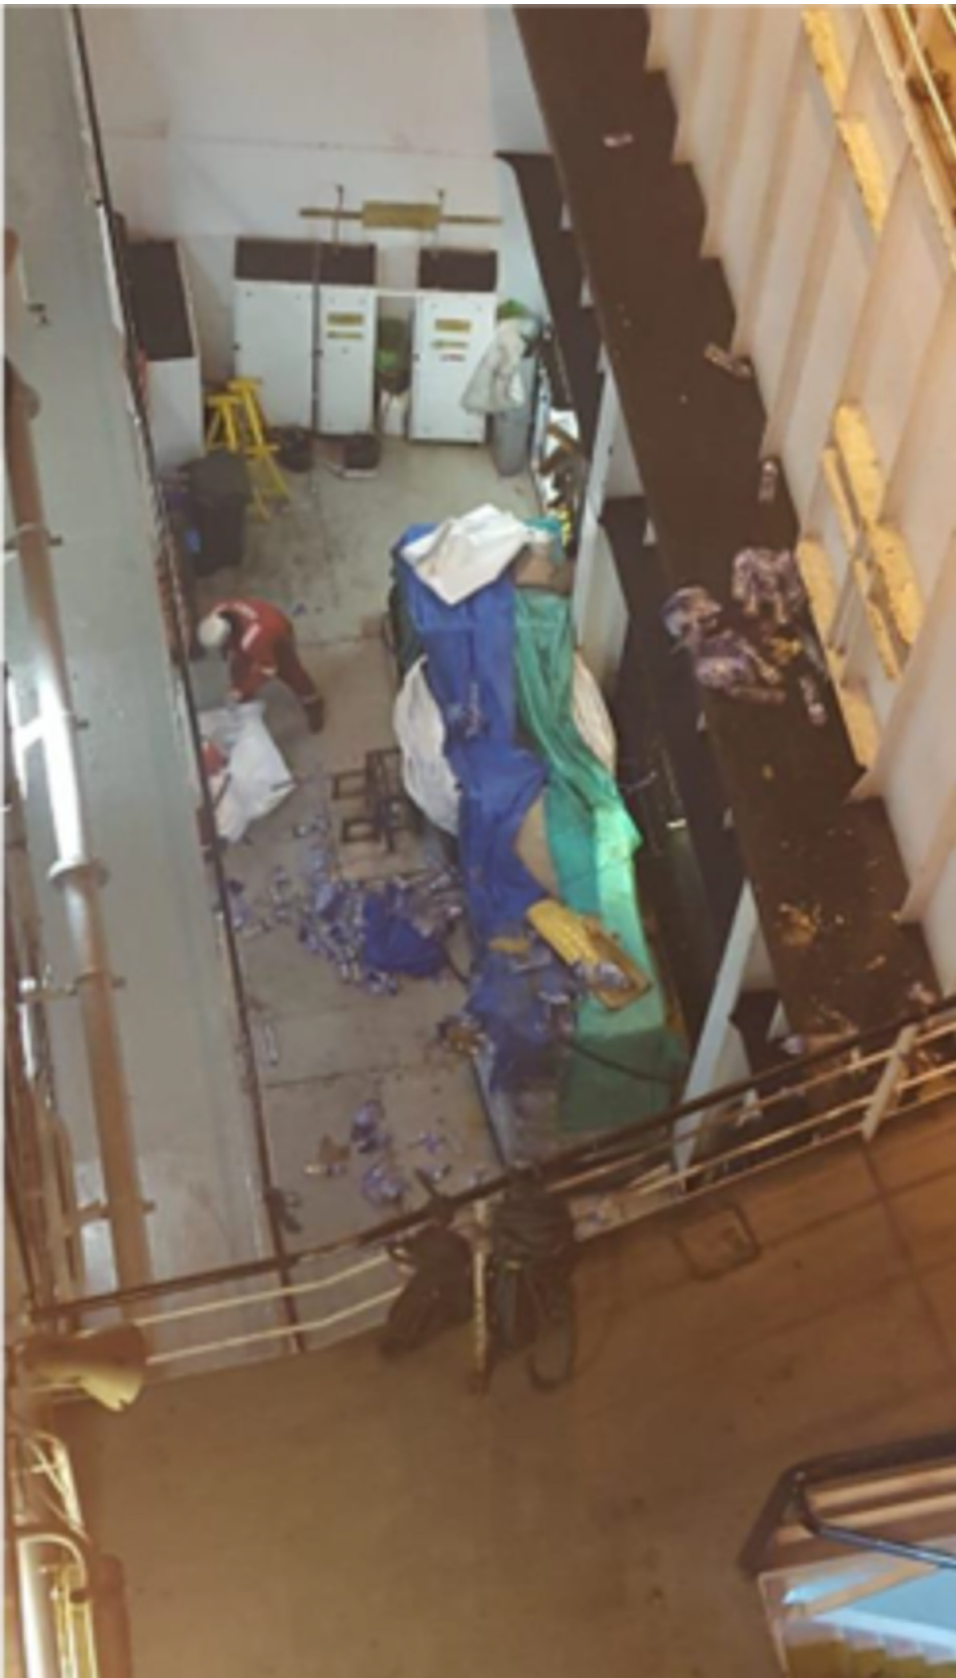
Riggers were attempting to lift a pallet of bottled water between decks of a vessel when the load hit an Intermediate Bulk Container (IBC), causing several packets of water bottles to fall from the load.

The water bottles were in packs of 6 (weight per pack = 9 kg) and fell approx. 11 m. This was considered a potential fatality based on the DROPS calculator.

- The lift was arguably unnecessary; there were already two pallets of water bottles on the lower deck. Also, alternate means of conducting the lift were not considered.
- The risk assessment/lift plan did not specify a safe method of slinging the load to prevent water from dropping should it collide with vessel structure.

- The risk assessment/lift plan did not identify suitable control measures for the activity of lifting into this deck whilst at sea – there were numerous challenges for lifting operations due to restricted space and visibility, which were not taken into account.

- Review task risk assessments and lift plans for lifting of stores, to ensure hazards, controls, slinging and securing methods are suitable, clear and specific, and with due consideration to the specific controls required to reduce the likely probability of the event reoccurring.
- Review the requirement for and positioning of stores to minimise lifts to be carried out at sea, e.g. sufficient stores loaded alongside or on main deck.
