Two battery issues – Step Change

Safety Flash Published on 28 May 2019 Generated on 16 January 2025 IMCA SF 12/19

Incident 1: Lifeboat Battery Explosion

Incident 2: Lithium Ion Battery Overheated Following Exposure to Water

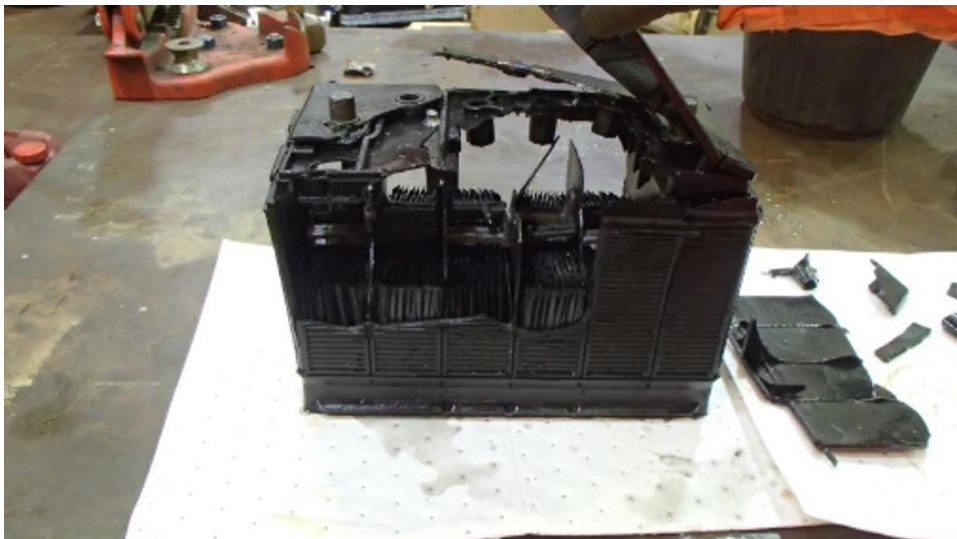
Weekly maintenance on a lifeboat involved charging the 12V starter battery, conducting voltage checks and starting the lifeboat engine.

Following the charging and completion of voltage checks, the battery compartment hatch was closed, and the engine started. At this point the battery exploded.

Pieces of the battery and fluid were expelled from the compartment having been partially restricted by the closed hatch lid.

- The battery installed was a wet cell lead/acid type, described by its manufacturer as ‘maintenance free’, although it could be topped up with distilled water. The model of battery was noted as not suitable for ‘installation inside the vehicle’.
- The battery had been overcharged weekly for over a year.
- Work instructions were not clear with regard to charging voltage levels required.

Overcharging caused a depletion of electrolyte within the battery and generation of an explosive mixture of hydrogen and oxygen gas. An internal electrical fault allowed for the ignition of this mixture upon start up.

- Ensure equipment is suitable for its intended use.
- Provide clear work instructions to avoid confusion.
- Ensure workforce has the correct core skills training/competency.
- Encourage the workforce to be assertive in and identifying and reporting operational discrepancies promptly to avoid inappropriate or unsafe conditions becoming the 'norm'.

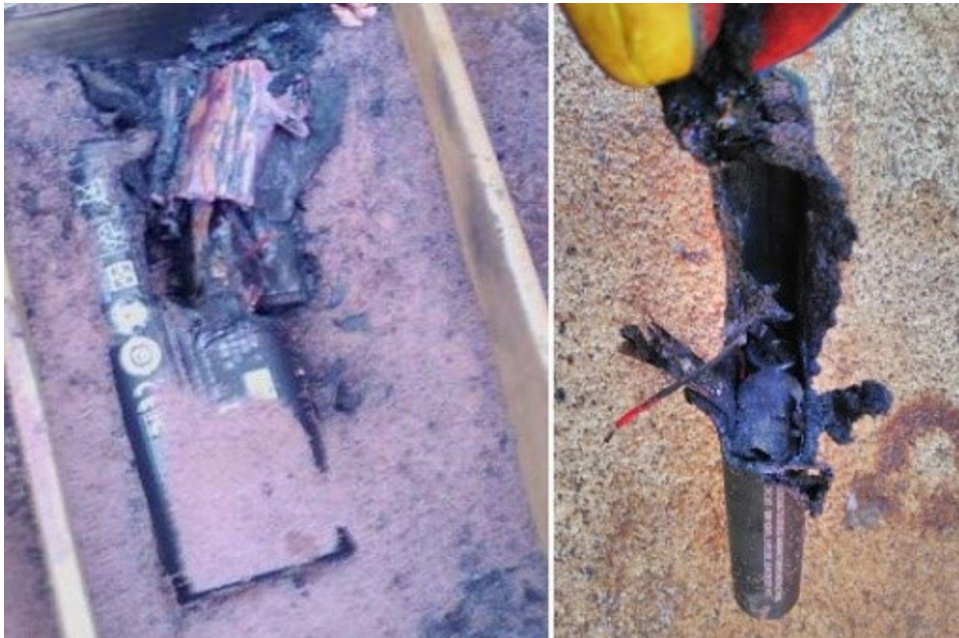
During a general fire alarm, a deluge system was activated and as a result, a piece of inspection equipment got soaked, causing the internal electronics to become saturated and short circuit.

Afterwards, the lithium-ion battery was removed and found to be overheating. Shortly thereafter, the battery started to smoke, and then catch fire.

Fortunately, the fire was controlled and extinguished immediately. However, the outcome could have been much worse.

The incident highlights the importance of protecting equipment from water ingress, along with the importance of ensuring that care is taken whenever equipment is being dried out following exposure to water.
