Differential pressure: Dummy choke ejected close to divers

Safety Flash Published on 16 May 2023 Generated on 28 January 2026 IMCA SF 12/23

A dummy choke insert was ejected from a water injection (WI) tree by force of differential pressure, while two divers were working nearby.

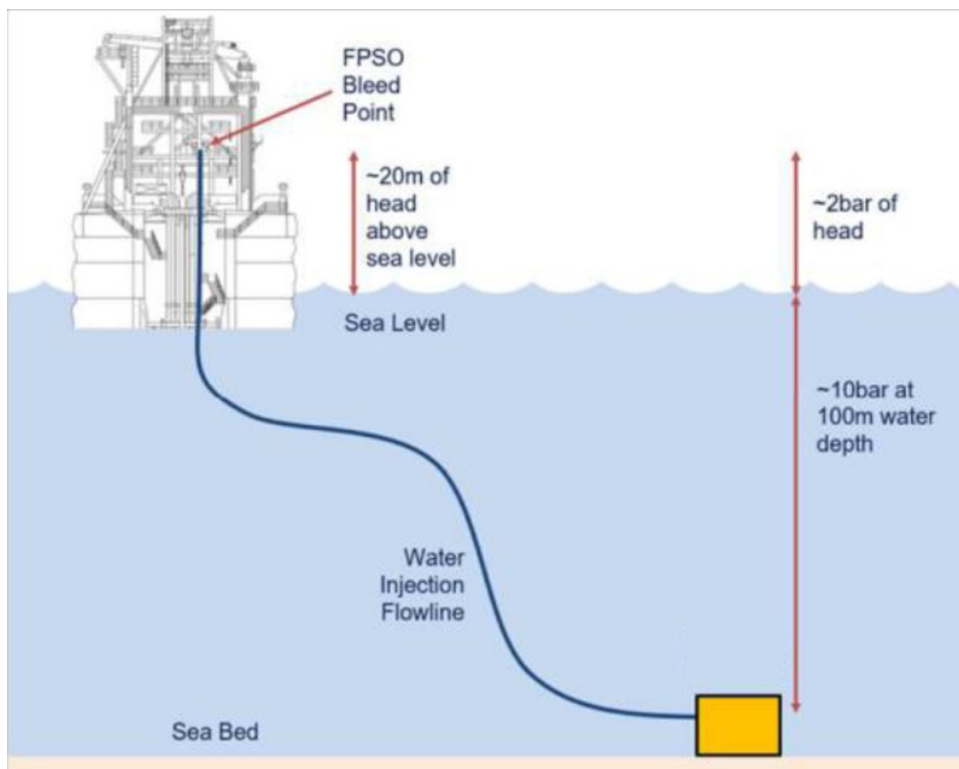
During the removal of the half shell clamps that retained the dummy choke insert, unexpected differential pressure from the flowline forced the dummy choke insert (85 kg in water) out of the choke valve body at significant force.

The two divers were loosening the clamp bolts around the dummy choke and were therefore close by when it ejected. Neither diver was in the direct line of fire; both were unharmed.

Image 1 – Initial gas release

Image 2 – Diver loosening bolts

Image 3 – Dummy choke ejection

- During the design of the dummy choke insert, the decision was made not to include a test port, which would have allowed venting of any pressure built up in the flowline. The port was not part of the supplier's standard design, and there was not enough time to approve a design change to include the port.

- The project procedure instructed that the Subsea Pressure and Monitoring Manifold (SPAMM) should be left closed, so there was no local vent path from the flowline.

- When pressure differentials in the system were noted prior to the dummy choke removal, there was no recognition that readings were not as expected, and no discussions within the team relating to venting off the remaining pressure.

- Based on previous experience at the tree, gas/fluid release had been identified as a hazard in the procedure and in the Hazard Identification and Risk Assessment (HIRA) - however, no parameters had been set as to the expected volume or duration of the release.

- Divers continued to work to loosen the clamp while gas/fluid was escaping from the choke, as the team had assumed that previous venting had been successful, and that they were safe to proceed.

- Our Member notes that *"the key point throughout was the failure to understand the exact pressure within the flowline, which was the residual 2 bar head of pressure from the riser after Floating Production Storage and Offloading (FPSO) venting"*.

- Design safety in at the early engineering phase of a project – in this case, inclusion of a test port.
- Ensure procedures and risk assessments are clear, unambiguous, and explicit in their requirements (rather than leaving things vague, ambiguous and implicit). This is particularly important when dealing with a pressurised system and/or with stored energy.

- When using subsea pressure gauges, ensure any reading anomalies are well understood, communicated to the full team, and recorded. If the gauge is behaving in an anomalous way, swap it out.

- When 'line of fire' or 'stored energy' is identified as a hazard, ensure that control measures are specific in how these hazards will be managed so that personnel are in a safe position. Relevant control measures may include: hard barriers, safe havens, extended hand tools or use of rigging.

- When carrying out diver intervention works involving barriers and isolations, ensure all relevant parties have had comprehensive training in isolations and barriers.

- Divers and Dive Supervisors should confirm a local vent is open before starting any work on pressurised systems.
- If any step in a procedure doesn't look right (e.g., local vent to be left closed when working on a pressurised system), **STOP the JOB**: Call an all stop and seek clarification.
