Differential pressure: Dummy choke ejected close to divers

Safety Flash Published on 16 May 2023 Generated on 23 January 2025 IMCA SF 12/23

A dummy choke insert was ejected from a water injection (WI) tree by force of differential pressure, while two divers were working nearby.

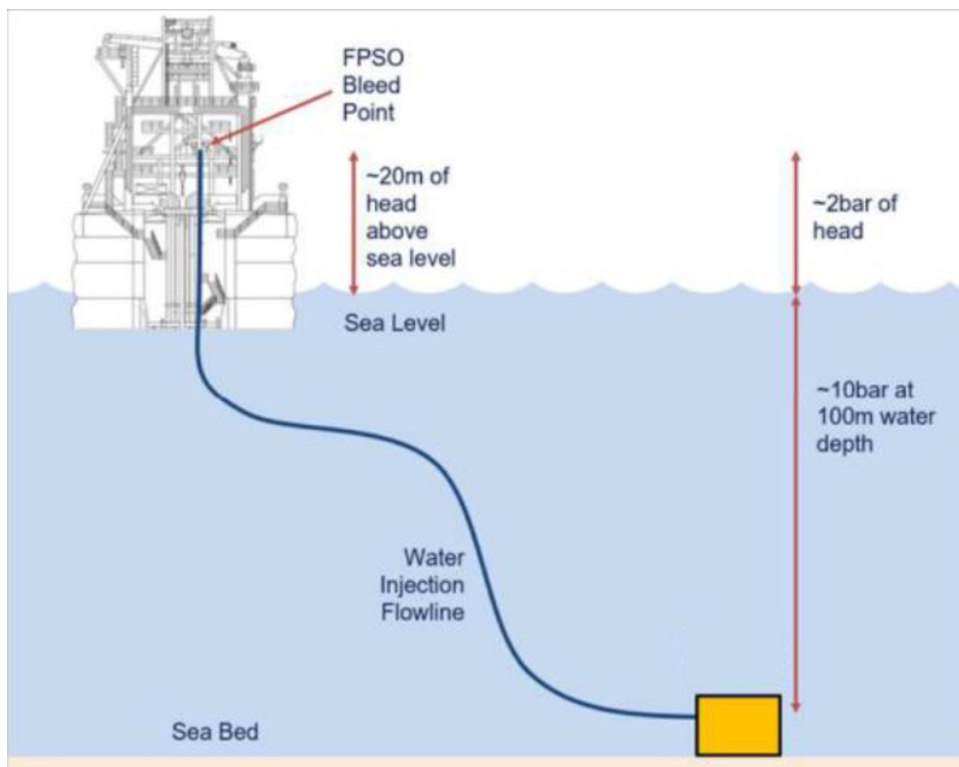
During the removal of the half shell clamps that retained the dummy choke insert, unexpected differential pressure from the flowline forced the dummy choke insert (85 kg in water) out of the choke valve body at significant force.

Image 1 – Initial gas release

Image 2 – Diver loosening bolts

Image 3 – Dummy choke ejection

- During the design of the dummy choke insert, the decision was made not to include a test port, which would have allowed venting of any pressure built up in the flowline. The port was not part of the supplier's standard design, and there was not enough time to approve a design change to include the port.

- The project procedure instructed that the Subsea Pressure and Monitoring Manifold (SPAMM) should be left closed, so there was no local vent path from the flowline.

- When pressure differentials in the system were noted prior to the dummy choke removal, there was no recognition that readings were not as expected, and no discussions within the team relating to venting off the remaining pressure.

- Our Member notes that *"the key point throughout was the failure to understand the exact pressure within the flowline, which was the residual 2 bar head of pressure from the riser after Floating Production Storage and Offloading (FPSO) venting"*.

- Design safety in at the early engineering phase of a project – in this case, inclusion of a test port.
- Ensure procedures and risk assessments are clear, unambiguous, and explicit in their requirements (rather than leaving things vague, ambiguous and implicit). This is particularly important when dealing with a pressurised system and/or with stored energy.

- When using subsea pressure gauges, ensure any reading anomalies are well understood, communicated to the full team, and recorded. If the gauge is behaving in an anomalous way, swap it out.

- When 'line of fire' or 'stored energy' is identified as a hazard, ensure that control measures are specific in how these hazards will be managed so that personnel are in a safe position. Relevant control measures may include: hard barriers, safe havens, extended hand tools or use of rigging.

- Divers and Dive Supervisors should confirm a local vent is open before starting any work on pressurised systems.
- If any step in a procedure doesn't look right (e.g., local vent to be left closed when working on a pressurised system), **STOP the JOB**: Call an all stop and seek clarification.
