High potential incident: Worker injured when opening a flanged assembly

Safety Flash Published on 3 July 2025 Generated on 28 January 2026 IMCA SF 12/25

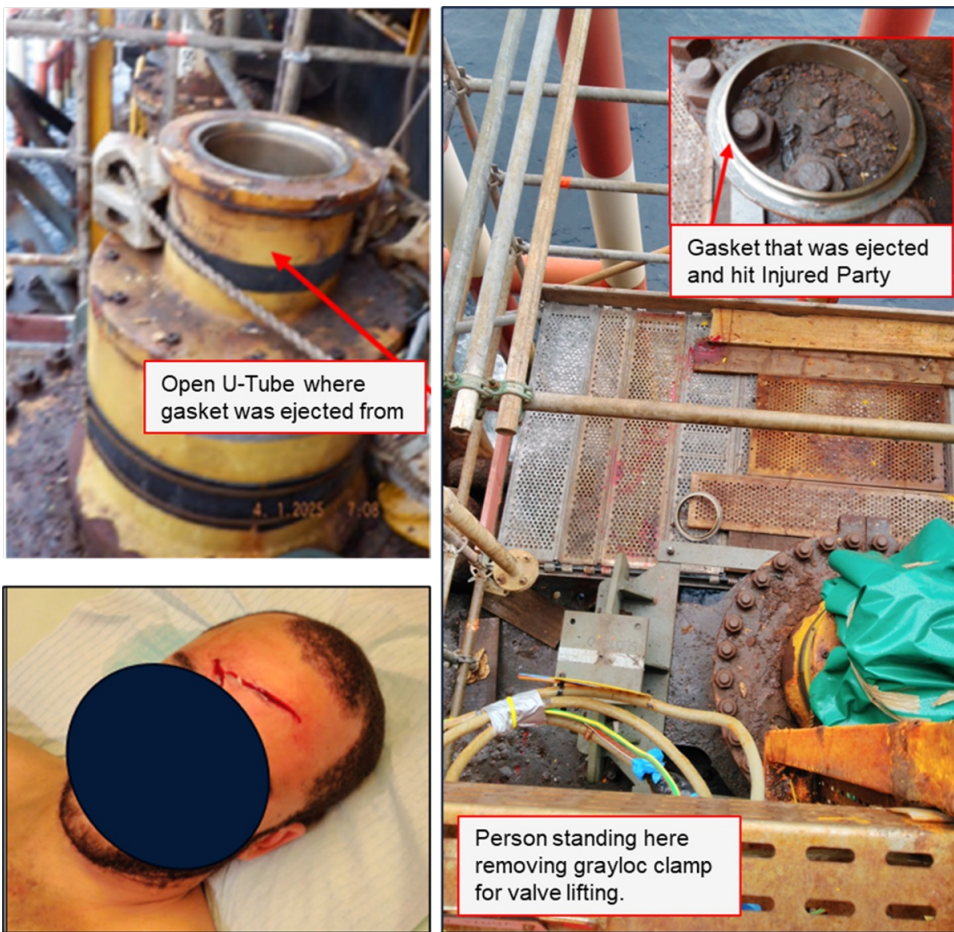
The team had, successfully and without any problems, already dismantled three valves / ESDV as per the plans for that night. As the last valve was being disconnected, the Grayloc connection between the jumper and valve, along with the gasket inside the line, were ejected with force. The ejected gasket hit one worker on the forehead, resulting in a bleeding wound. The injured person remained conscious throughout and was assisted to the medic for treatment. The worker was treated by the medic and received seventeen stitches to the wound.

- The lines had been flushed and isolated two weeks earlier and an isolation handover procedure and isolation certificate provided to the contactor.
- The activity was being carried out under the Site Permit to Work and in conjunction with SAT diving activities.
- No further check of the line was performed prior to starting the disassembly.
- Adjacent lines had been worked on and dismantled with no pressure present.
- Work by divers subsea had taken place on lines in the circuit allowing water to ingress.

- Unidentified pressure in the line caused the gasket to be ejected with force;
- Lack of monitoring of system behaviour between isolation and start of the task;
- Lack of safety controls – no-one had manually rotated the valve and vented the system after actuator removal, thus ensuring no pressure.

- **Never assume the absence of pressure** – always check to monitor or identify pressure before starting work.
- Our member implemented:
 - Pre-start work safety checks performed with an appointed safety leader to ensure that all safety controls are in place.
 - Additional “hold point” in the task plans for checking / venting of subsequent lines for pressure.
 - Close monitoring of subsea lines during and following diving operations on lines.
