Improper slinging of cargo

Safety Flash Published on 1 November 2001 Generated on 28 January 2026 IMCA SF 13/01

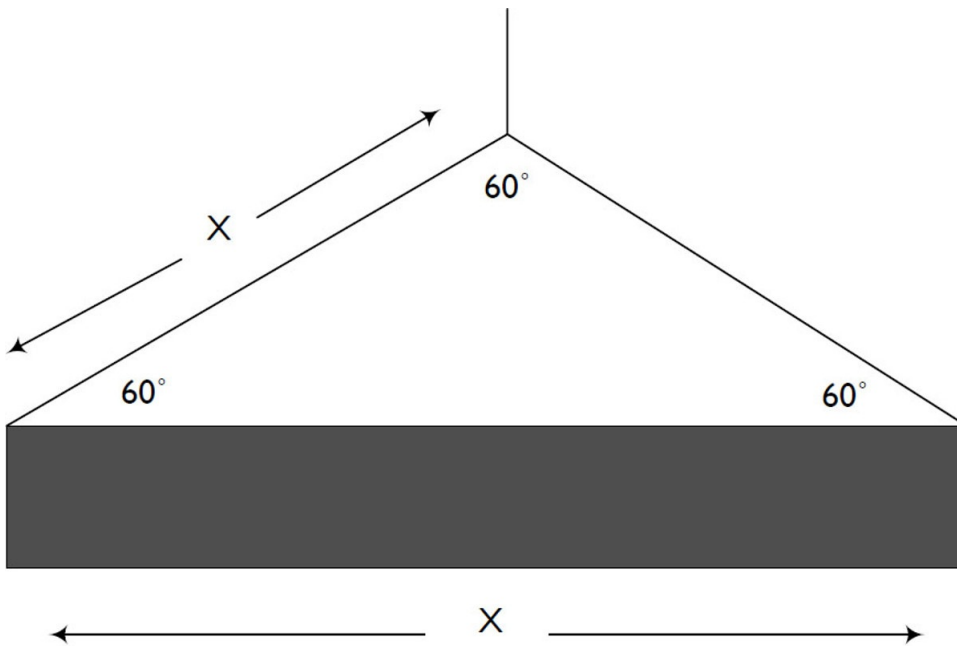
Figure 3: Rules of thumb

- Use the same number of pickup slings as the number of o-rings on the load rigging.
- Each sling leg should be at least equal distance between the load pickup points (forming an equilateral triangle) regardless of whether using a single stinger or two legged hook-up. This will always give the preferred 60 degree sling angle.
