## Open lifeboat – corroded tie band side plates

Safety Flash Published on 21 November 2006 Generated on 25 April 2025 IMCA SF 13/06

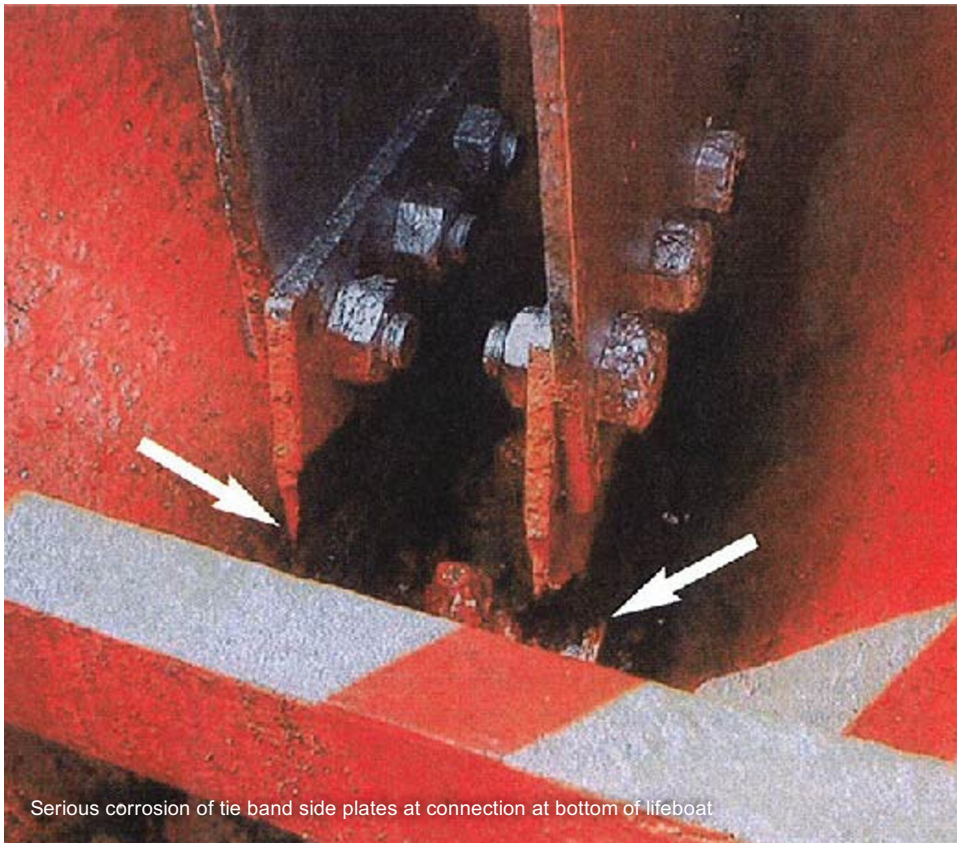
It is believed that the corrosive environment at the bottom of the lifeboat, combined with lack of maintenance over time, led to extensive corrosion of the tie bands. Access to them can be difficult, hampered by the presence of debris and bilge water.

Further tests were made of other similar lifeboats, and the tie bands on these lifeboats were also found to be heavily corroded. Though well painted and appearing to be well preserved, it was clear that these were in poor shape.

- Lifeboat tie bands, hooks and release systems should be inspected and maintained according to the manufacturer's recommendations, and be included in the vessel maintenance schedule.
- All items encompassed by scheduled inspections should be properly examined on a regular basis.
- Access to, and cleaning of, the tie bands side plates should be made prior to inspection of lifeboats.
- Special attention should be paid to the cleanliness of lifeboat bilges.
- Corrosion damage of this sort may also occur on totally enclosed or partially enclosed lifeboats.

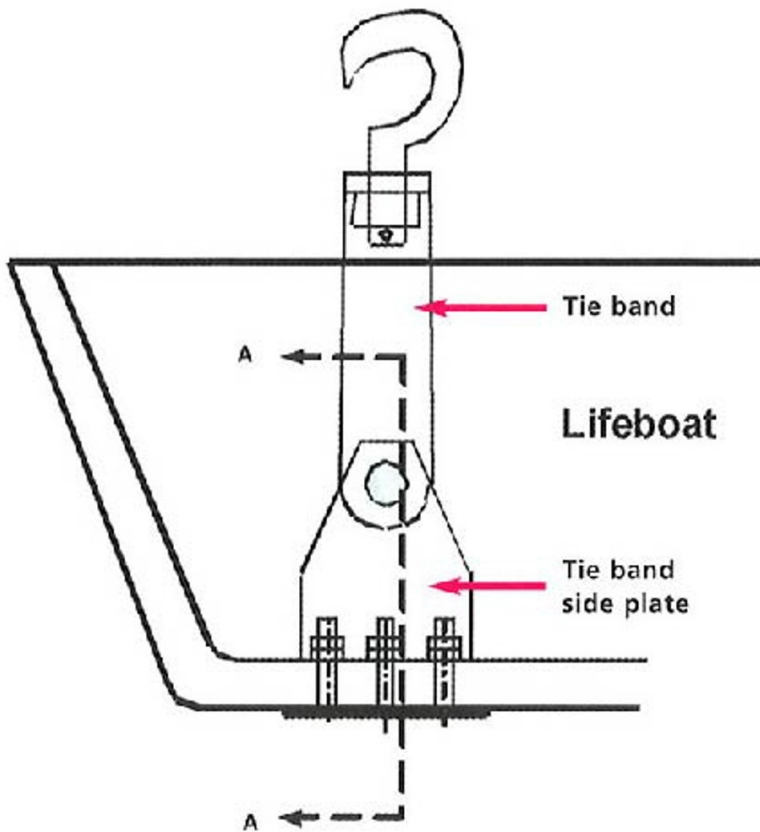
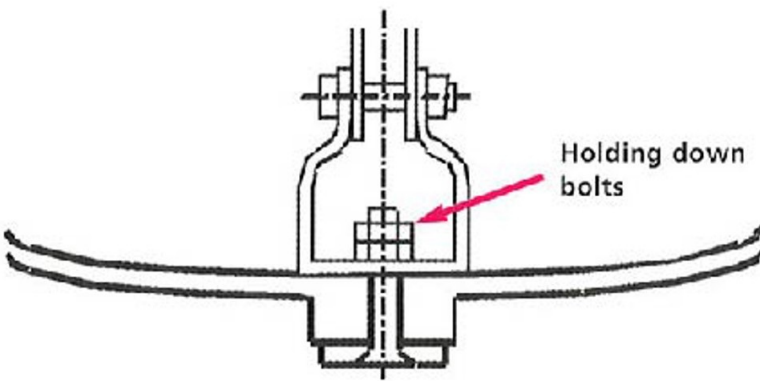
**Section A-A**

Tie band side plates connected to the lifeboat with three bolts and with one counter-nut per bolt
