## Near-miss: Dropped taut wire clump weight

Safety Flash Published on 25 November 2011 Generated on 28 January 2026 IMCA SF 13/11

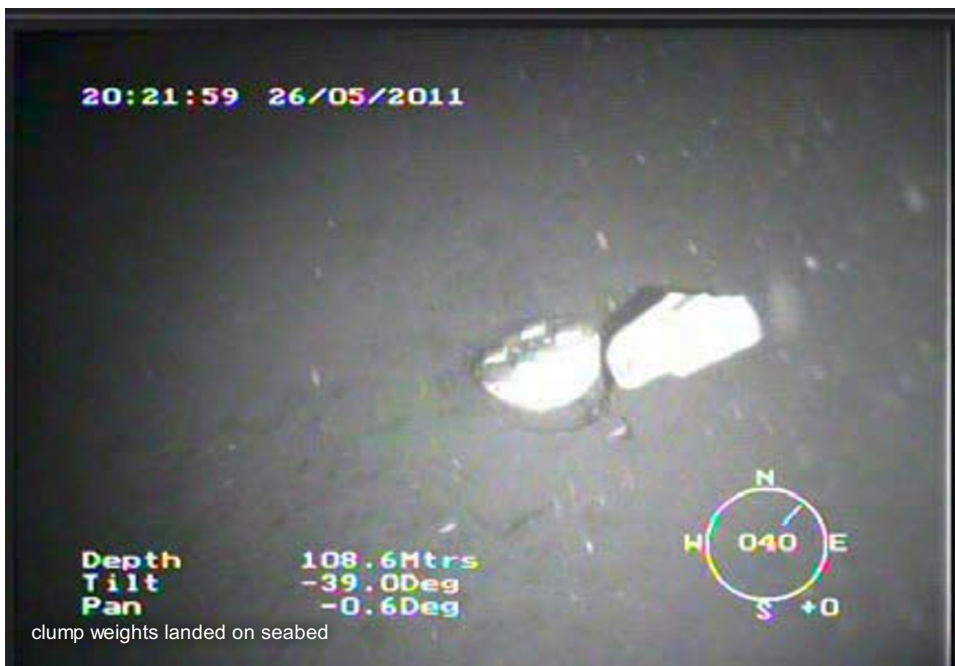
The ROV continued to monitor the starboard clump weight and identified an area under it suitable for landing. The starboard taut wire was then deployed and taken back into the DP system, and the port taut wire and clump weight recovered to the surface. During recovery, as the port taut wire was being slewed inboard, the wire parted and the clump weight (315 kg) fell straight downward, well away from the divers working on the seabed, and landed clear of any subsea assets.

- A worn wire guide with sharp edges caused unnoticed damage to the taut wire, resulting in the wire parting.
- Procedures for protecting divers and subsea assets from dropped objects were properly followed and this prevented a potentially much more serious incident.

- The existing starboard taut wire was replaced in its entirety in case further damage had been sustained.
- The damaged wire guide was assessed and temporary repairs were undertaken.
  - A complete new unit would be fitted at the next opportunity (dry dock).
- There would be a review of relevant inspection and maintenance routines.
