Failure of lifeboat release hook mechanism

Safety Flash Published on 17 July 2014 Generated on 28 January 2026 IMCA SF 13/14

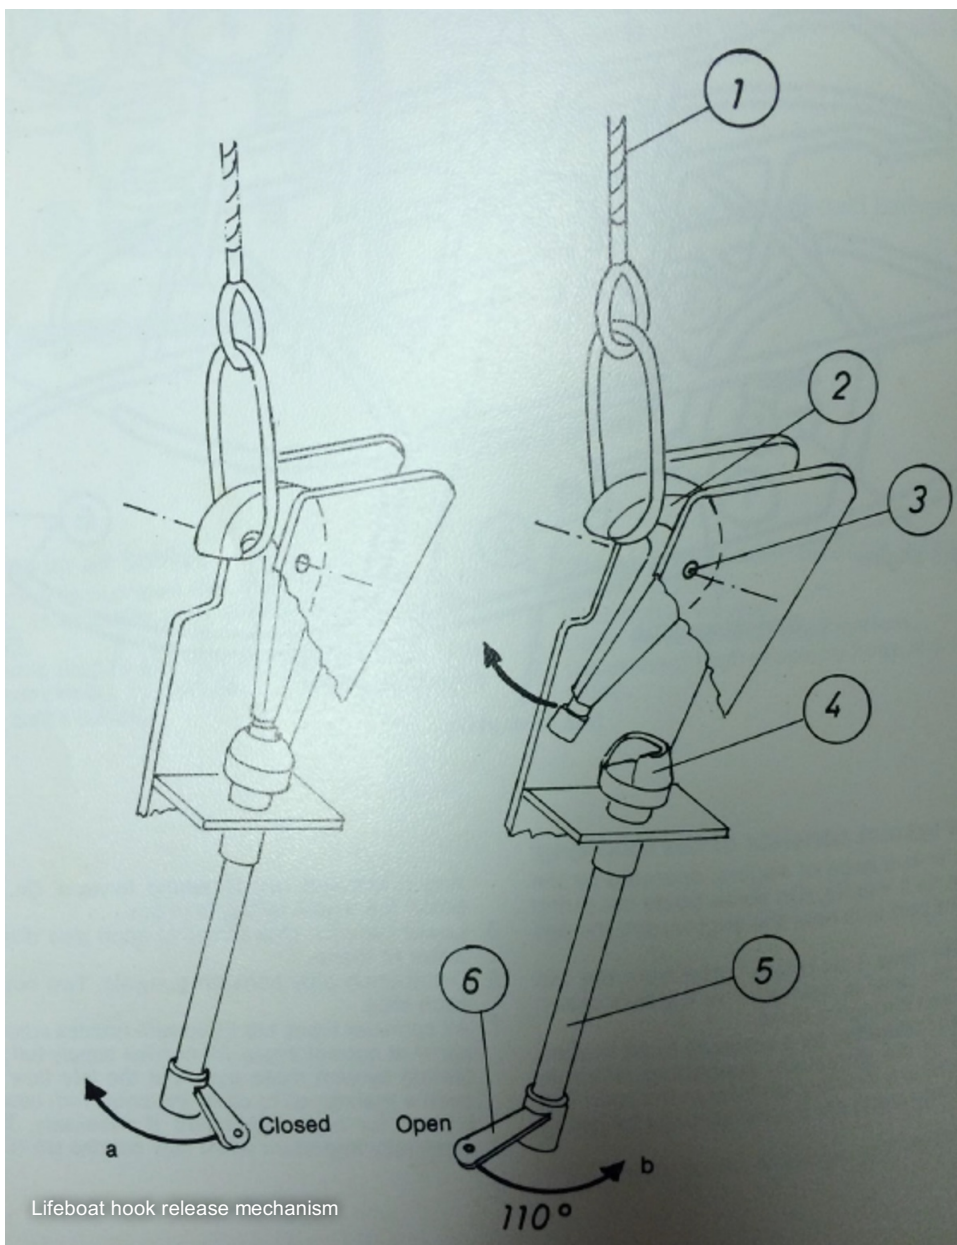
The release hook system in place onboard the vessel is of the Schat-Harding H-80, 'on-load' release type. The basic overview of the system is shown in the figure on the left, with the components noted below.

The locking lever (component 6) is twisted 110 degrees at the aft release point and this command is replicated at the forward hook release and the main hook lever (locking cup)(component 4) latches or unlatches the release hook.

The current design of the system does not give the operator direct indication that the forward hook is correctly locked. A single indicator serves both the Master (aft) and Slave (forward) locking systems, but only the position of the aft hook is positively indicated.

1	Davit fall
2	Aft hook
3	Hook pivot point
4	Main hook lever
5	Locking shaft
6	Locking lever

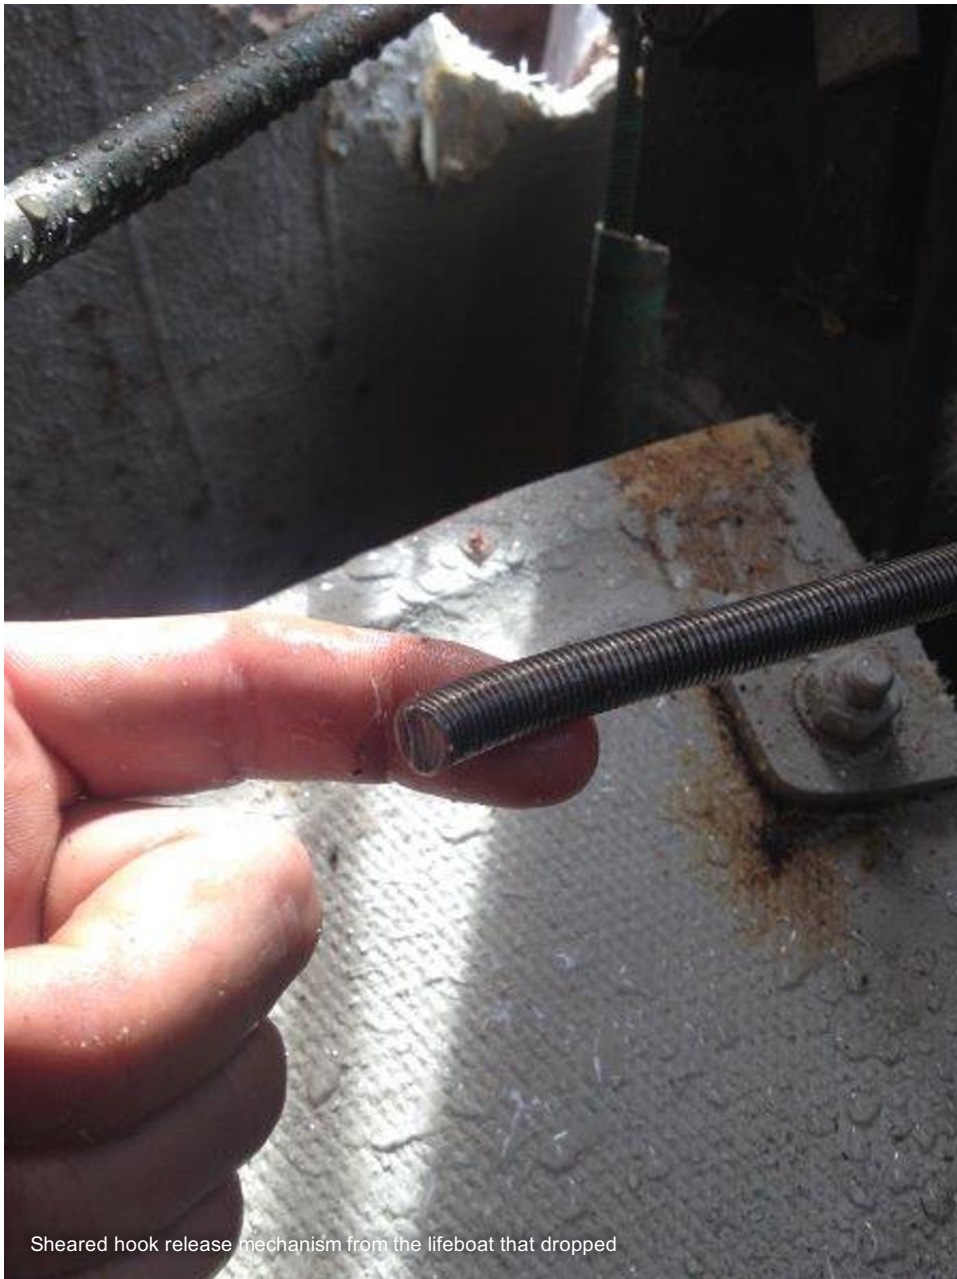
Sheared hook release mechanism from the lifeboat that dropped

- The hook release mechanism linkage was found to have failed (sheared) – see Figure 2 – at the forward end of the lifeboat. This is likely (pending final report) to have been caused by misalignment of the hook during re-attachment and/or fragile design of the hook release mechanism linkage.

This photograph shows the linkage rod that sheared on the forward release hook mechanism on the failed lifeboat. With the linkage sheared, the lifeboat release hook was not fully engaged, resulting in the hook releasing.

- Check for integrity and potential damage.
- Ensure that the latching mechanism is fully engaged.
- Ensure that there are 'routine' checks that all hooks are engaged prior to launch, on completion of recovery and during 'routine' lifeboat inspections.

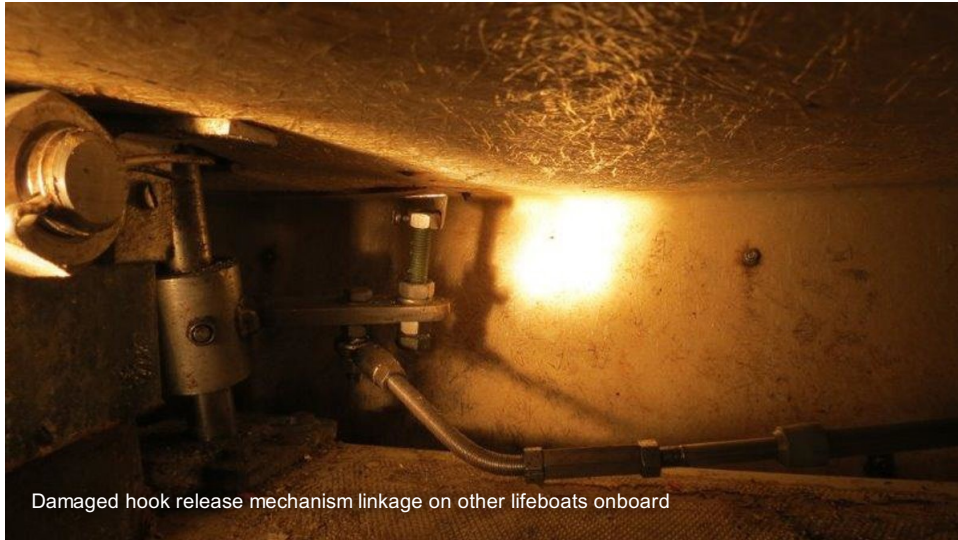
- Further inspection onboard found that the forward release mechanism linkage was severely bent (see Figure 3) in one of the other three lifeboats.
- As a result of the above noted damage, a total of two of four lifeboats were found to have release hooks that were not fully engaged.
- Immediate inspection of all lifeboat release hook mechanisms, irrespective of design with the following pointers.

This photograph shows the release hook mechanism linkage at the forward locking mechanism. The arrow indicates the area of severe deformation of the linkage rod, caused by the misalignment of the hook and/or fragile design. The blue line represents the correct alignment of the linkage rod. In this condition, the lifeboat hooks are not fully engaged.
