Two dropped object near misses

Safety Flash Published on 22 June 2018 Generated on 22 January 2025 IMCA SF 13/18

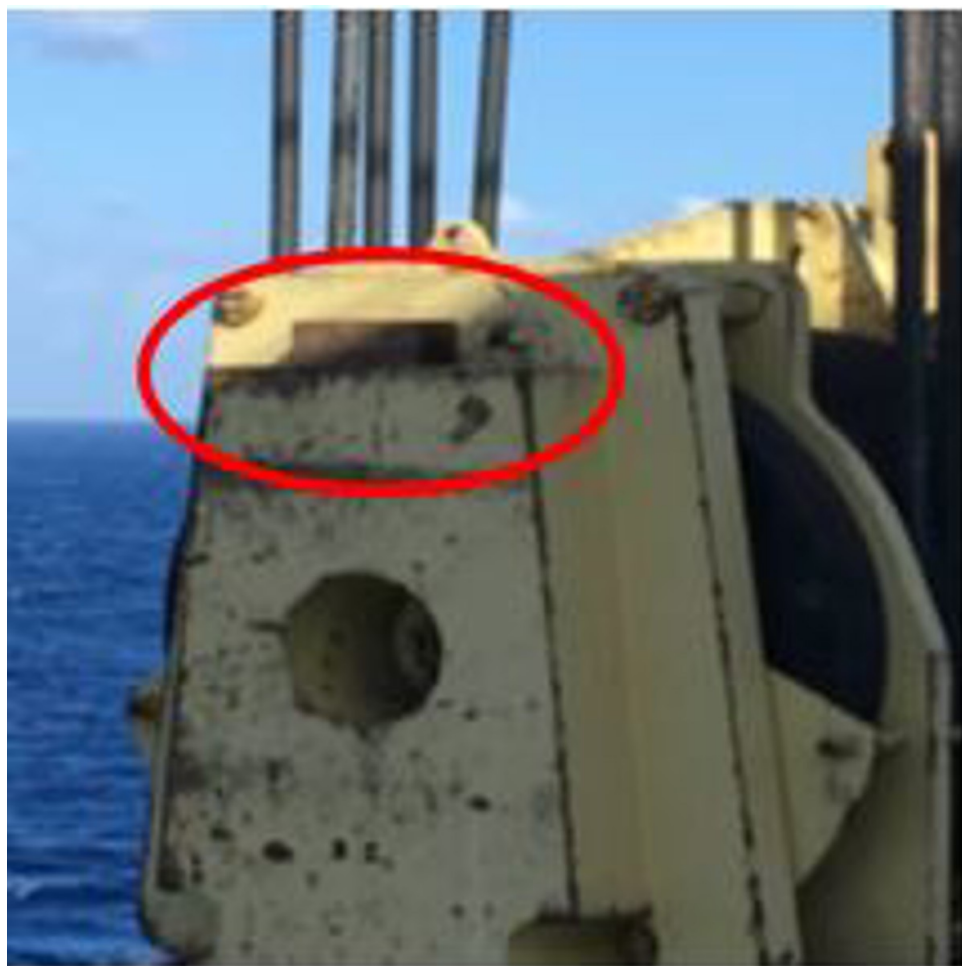
Incident 1 – Wooden block laying in top of main hoist block

During a voyage in good weather conditions, the Captain decided that the vessel would sail with the cranes secured on deck. On the second day of the trip, the Captain was looking at the main hoist block of the forward crane, which was secured at the same height and just behind the bridge, when he noticed a 30cm long piece of 10×10 timber lying on the side of the hook.

The piece of timber was most likely placed there during a re-reeving operation some months previously, although the investigation could not confirm this and it may have been there even longer. The piece of timber was immediately removed.

- Ensure that your work area is suitable for using loose equipment (lying on deck, platforms, gratings).
- Ensure that your work area is checked for loose equipment during your job.
- Ensure that your work area is cleared up after completion of your job.
- It is good practice to use a tool lanyard when working at height with tools.
