Lifting operations: wire hoist rope failure

Safety Flash Published on 28 April 2020 Generated on 20 January 2025 IMCA SF 14/20

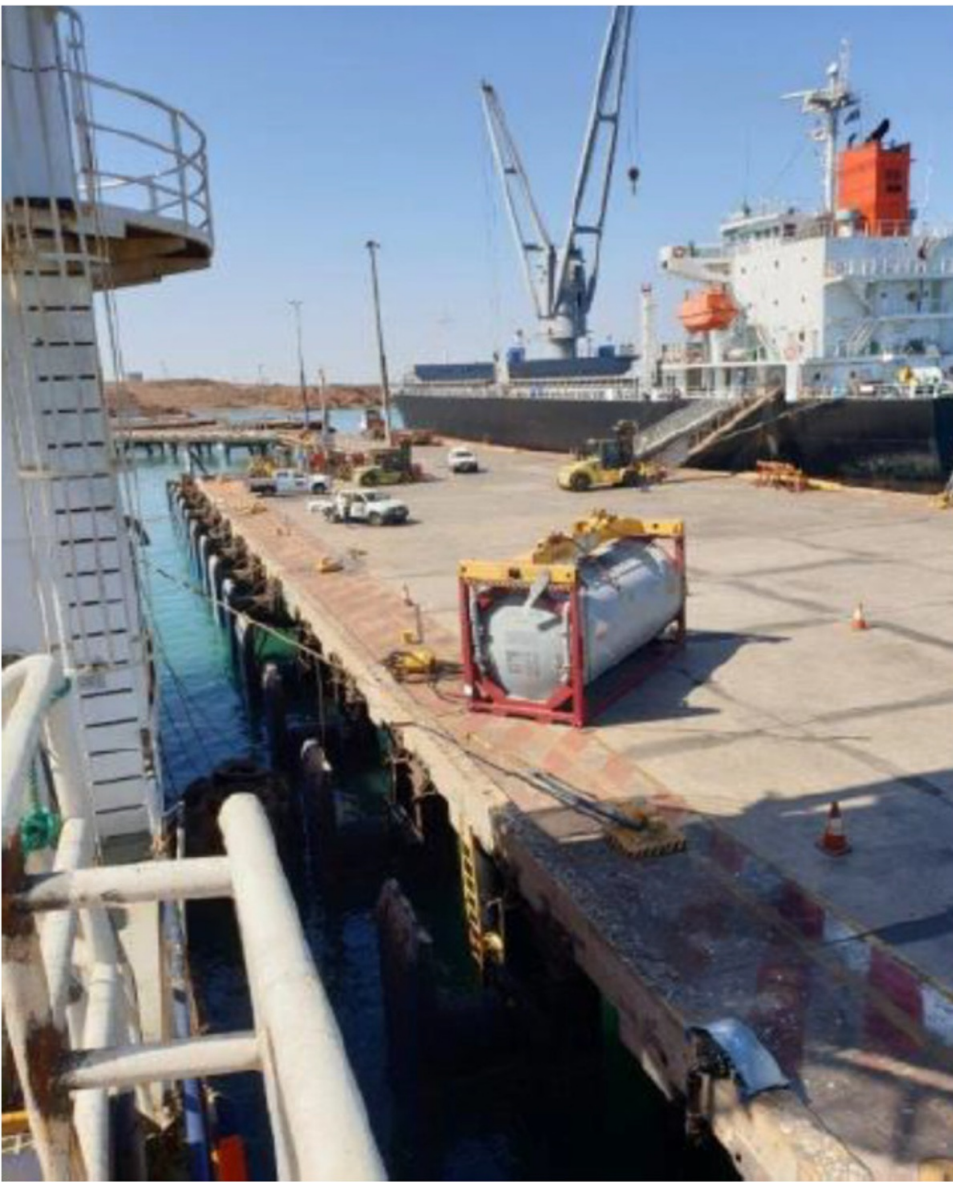
When conducting a standard lifting operation of a 24.5te storage vessel and lifting frame (approximately 36% of the crane 70te maximum rated capacity) the wire hoist rope (WHR) failed causing the load, main block and length of wire to drop approximately 3m to the wharf. No personnel were injured.

The maintenance, inspection, and testing regime applied to the WHR was consistent with general industry practice, guidelines, and company requirements and included third-party examination and certification. However, localised internal corrosion of the wire hoist rope (WHR) went undetected.

The metallurgical examination conducted on the wire hoist rope after the incident concluded that the wire hoist rope failed by a ductile overload mechanism following corrosion damage during service, particularly of the core wires. The lack of protective zinc galvanised coating on the wire hoist rope was a significant contributor to the eventual failure.

- Reliance on 'industry practice and guidelines' alone when maintaining, testing and inspecting wire hoist ropes may not be sufficient. Frequency of use, intended loads, environmental conditions, time in service, and criticality of the wire hoist rope should be specifically considered.
- Implement crane wire maintenance regimes for specific individual wire rope types using original equipment manufacturer input coupled together with a competent person's assessment of the risks, giving due regard for the operating environment and intended use of the crane/wire rope.
- Establish criteria to determine when and how magnetic wire rope (MRT) testing should be applied (frequency, triggers, length of wire).
