## Two injuries

Safety Flash Published on 6 May 2021 Generated on 21 January 2025 IMCA SF 13/21

A Member reports two injuries during operations, highlighting the need for continued vigilance and care in everyday activities.

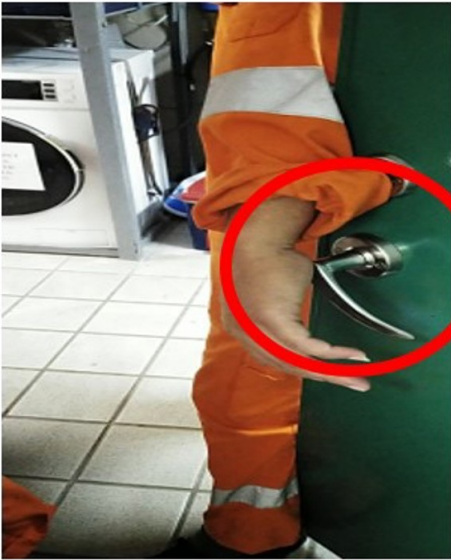
During a routine inspection of the air conditioning plant room, the engineer caught his sleeve on the latch of the AC room door and due to the lower pressure within the room, the door closed and slammed shut catching the tip of his finger.

*Crew Member Caught  
Overalls On Door*

- He had his sleeves rolled up making snagging more likely.
- There was no indication that the AC room door would slam shut because the room was at a lower pressure than elsewhere.
- The spring loaded self-closing device on the door was set to slam the door shut due to the lower pressure in the AC room, as it would not close properly under any other setting.

- A sign was posted indicating that the door was a pinch point owing to its tendency to be pulled shut by the lower pressure in the AC room.

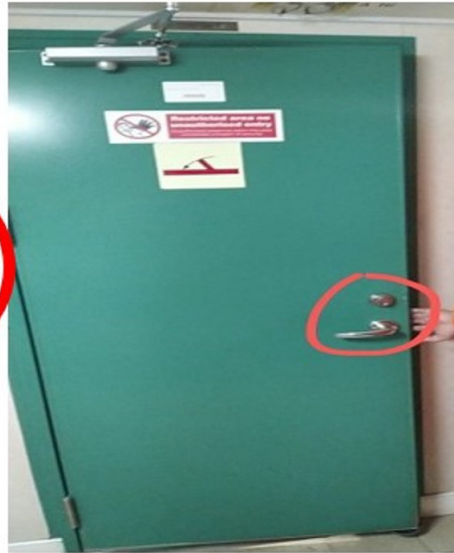
*Door Closed On Finger*
