Failure of pallet lifters

Safety Flash Published on 23 December 2011 Generated on 14 January 2025 IMCA SF 14/11

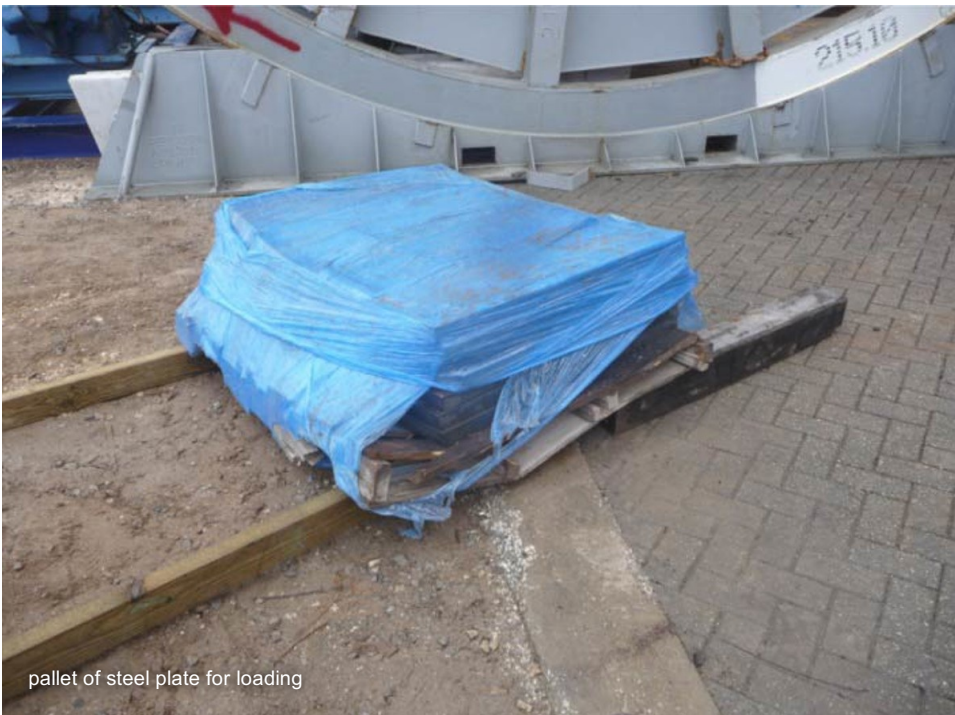
A pallet lifter with a 2.0T SWL was being used to transfer pallets of steel plate on to the main working deck of a vessel. The plate being loaded was delivered on pallets and wrapped with plastic covers. The weight of the load had not been provided by the supplier and was not known to the lifting team prior to the lift.

This lifting operation involved inserting the pallet lifter forks, and the load being raised slightly to allow a secondary cargo strap to be positioned around the load and prevent any movement during the lift. However, as the load was raised approximately six inches off the quayside to attach the cargo straps, the plates moved, sliding forward and to the left of the forks. The pallet lifter and load was then returned to the quay and the forks removed from the pallet. Once the pallet lifter had been removed from the pallet it was evident that the left fork had been twisted due to the load moving and overloading the pallet lifter fork.

pallet of steel plate for loading

- A permit to work and lift plan had been completed for this operation but no consideration was given to the lack of information about the load to be moved or the limitations of the pallet lifter. This should have been highlighted in the lift plan risk assessment and the toolbox talk prior to moving the pallets. Hazard awareness and correct lifting procedures were not applied during this lifting operation.

- As the steel plate loads had no clear indication of the weights contained on each pallet, a lifter which has a SWL of 2.0T should not have been used without confirmation that the working limits would not be exceeded by the load.
- Good practice for transporting of plate onto vessels should be to transfer the load into a certified lifting basket ensuring the lifting of all plates in a contained and controlled manner.
