MAIB: Who is in control?

Safety Flash Published on 12 June 2023 Generated on 23 January 2025 IMCA SF 14/23

Control was lost of a vessel and it almost ran aground.

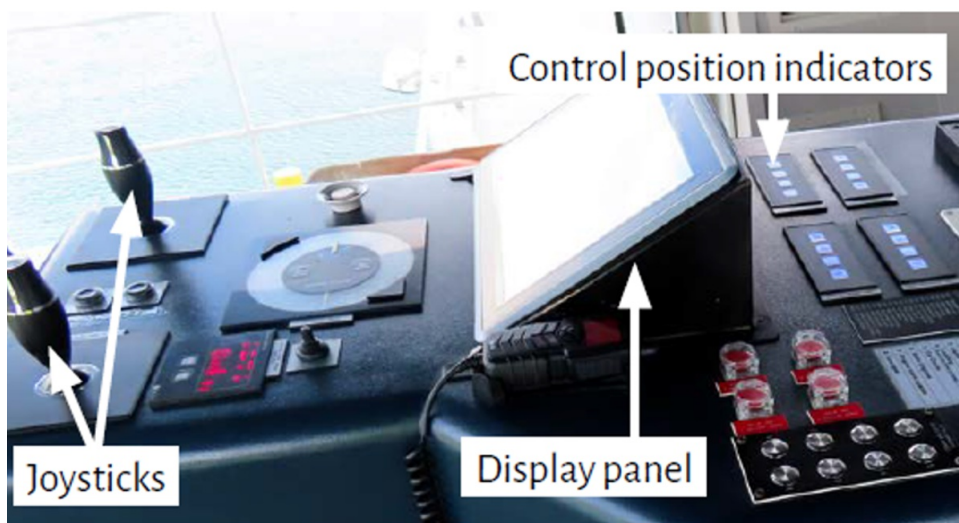
The Master was using the starboard console to manoeuvre the ferry out of port on the morning of the incident. The helmsman pressed the command button on the centre console to request control as normal and the audible tone sounded. The master, believing control had been passed, set the starboard console's joystick to the zero position. However, the audible tone continued. This was confusing. Neither the Master nor helmsman knew who was in control. The ferry slowed and swung to port. The bridge team attempted to take control at each console station and in doing so the control passed backwards and forwards many times.

The audible tone stopped shortly afterwards, indicating that the transfer process had timed out.

- The angle of the control display panels made it difficult to see which console was in control – previous modifications to the position of the display panels had inadvertently made it harder to see them.
- Confusion arose and neither the Master nor helmsman knew who was in control.

- **Equipment:**
 - With dual or other complex control systems, ensure there is a robust system for identifying which console has control at any time.
 - Control indications should be unambiguous and any modifications need to be carefully considered so that the fixing of one problem does not create another.
- **Training and competence:**
 - When the equipment did not operate as expected it took time for the bridge team to regain control. This circumstance was in the manual – greater familiarity with procedure may have quickened the bridge team's response to the loss of control.
