Collared eyebolts as lifting equipment

Safety Flash Published on 15 June 2017 Generated on 24 January 2025 IMCA SF 15/17

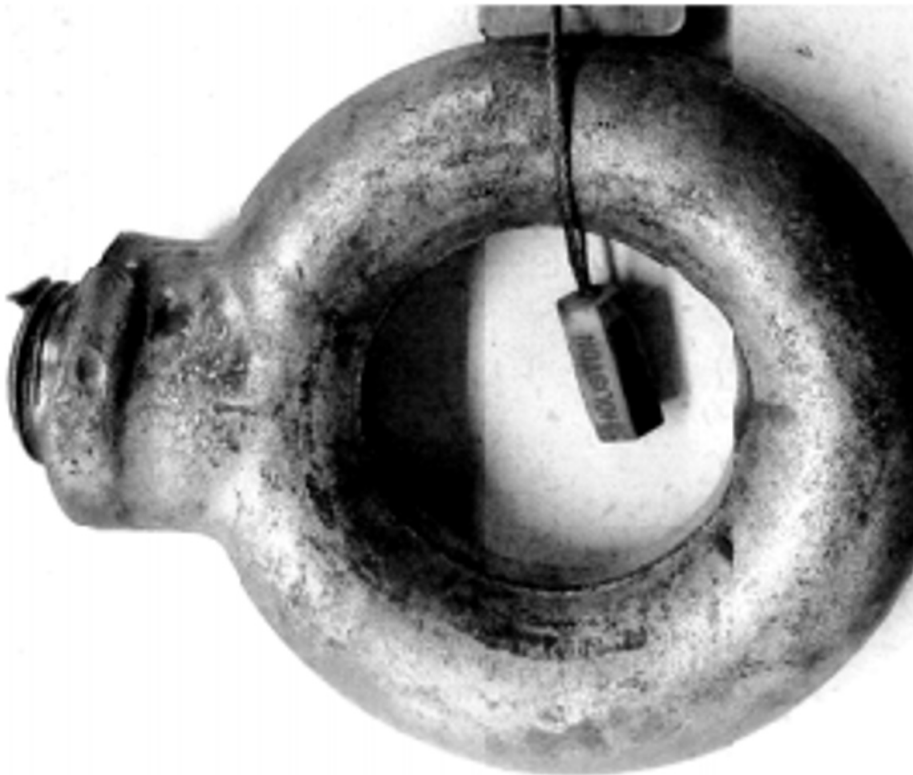
A piece of equipment was being lifted during maintenance and repair, when one of the two collared eyebolts used to lift it, sheared.

The piece of equipment, which weighed 21.7 tonnes, fell a distance of 1.2-1.8 m. There were no injuries.

- The lifting equipment was configured such that the direction of pull was at an angle to the shaft of the eyebolt, so that a “fleet angle” from the vertical was created. Such an angular load reduced the Working Load Limit of the eyebolt to a significant degree.

- The collar of the eyebolt was not fully flush with the body of the piece of equipment being lifted, causing a sheering force due to the fleet angle to be applied to the shaft of the eyebolt, instead of the load being spread across the eyebolt and the surface of the equipment being lifted (as per design).
- A **root cause** identified was **ineffective lift planning**.
