Near-miss: Snagged lifting bridle

Safety Flash Published on 15 June 2017 Generated on 16 January 2025 IMCA SF 15/17

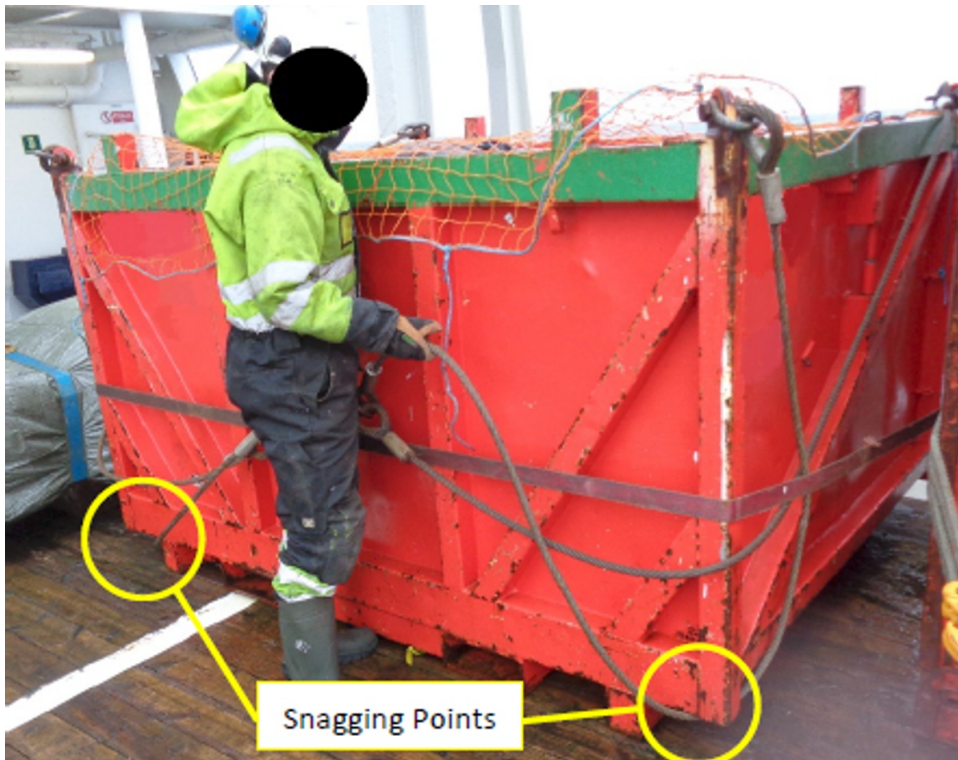
The incident occurred on a platform supply vessel (PSV) alongside an installation in calm weather. Whilst discharging an open top mini basket type unit, one leg of the basket's lifting bridle snagged on the bottom corner of the unit, almost causing it to tip over.

- Container manufacturers to consider re-engineering units to eliminate/reduce snagging hazards.
- The length of the unit lifting bridle will be measured to ascertain if it was too long, leading to this incident.
- The installation crane operator to be informed about any lifts with a potential to snag.
