Fuel spray fire

Safety Flash Published on 20 July 2018 Generated on 28 January 2026 IMCA SF 15/18

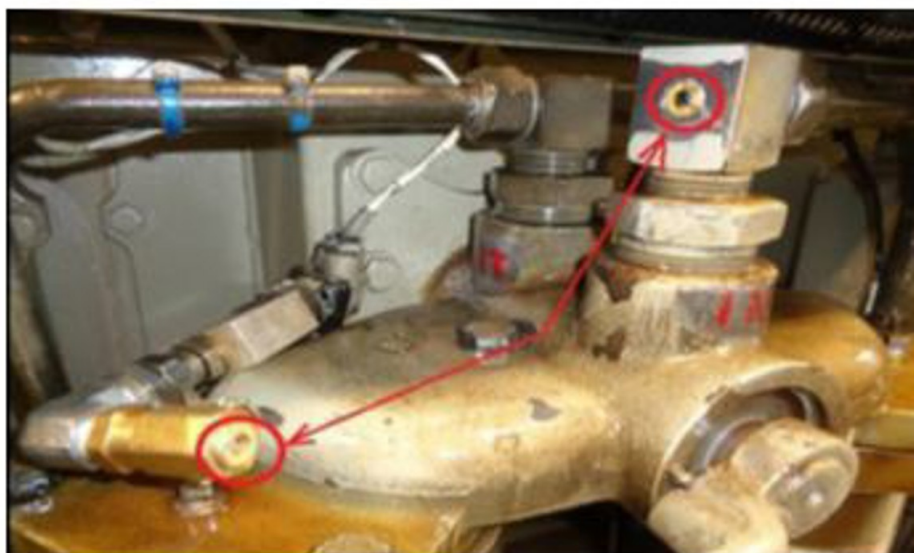
The vessel had been forced to stop operations due to foggy weather. A high-level alarm was sounded on the forward bilge. Investigation of the alarm showed that the forward bilge was full of fuel oil; the fuel was spraying from the port main engine onto the engine room plates.

Failed connection as found by duty engineer

Upon further inspection, it was found that the fuel oil secondary filter differential pressure sensor isolating valve on the port main engine had cracked, and this was causing the fuel spray. Approximately 1m³ of fuel was lost.

- The failure of the valve was caused by a combination of engine vibrations and the weight of assembly acting on the male threaded section of the brass valve.
- The pipe arrangement had been altered from the original set up because of pressure fluctuations – this interfered with the proper functioning of the sensor; the MSF notes that the long-term effect of this alteration was perhaps not properly assessed by the manufacturer prior to this alteration.

- Replacement of the brass valve fitting with a stainless-steel equivalent.
- Addition of a deflector plate above the valve to prevent future failure and prevent fuel spray from reaching the hot engine.
