Have a regime when the current's abeam – ensure adequate manoeuvring space!

Safety Flash Published on 1 July 2019 Generated on 22 January 2025 IMCA SF 15/19

The United States Coast Guard (USCG) has issued **Safety Alert 03-19** relating to the consequences of manoeuvring in high current environments.

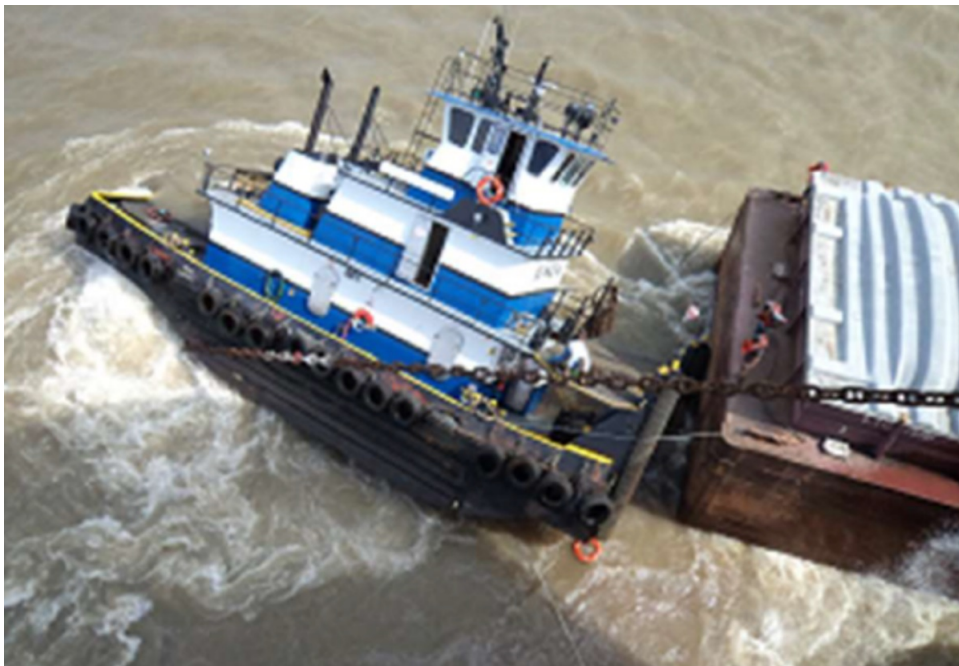
Recently there were three marine casualties that resulted in the sinking of towing vessels on the Lower Mississippi River. One of the casualties resulted in a fatality. These cases are all under investigation by the Coast Guard, but the preliminary fact finding indicates there are some similarities between the three incidents.

In all three cases *'towing vessels became pinned against another object in an aspect that exposed the vessel broadside to very strong currents.'* Once in that position, the vessels could not recover and sank.

- Avoid transiting between two anchored vessels, between two barge fleets, or between any other set of stationary objects.
- Minimise the number of operations which require the vessel to be positioned beam-to the current.
- Establish a minimum distance between the towing vessel and another vessel/object prior to conducting any operation that requires the vessel to be positioned beam-to the current.
- Recognise the risks involved in operating under high current conditions and weigh those risks before attempting to cross in front of stationary objects or attempting an operation that requires the vessel to be positioned beam-to the current.
