## Well drilled in the wrong place breaches railway tunnel

Safety Flash Published on 1 July 2019 Generated on 28 January 2026 IMCA SF 15/19

At a large construction site in a big city, contractors drilled an exploratory well in slightly the wrong place and as a result drilled into the wall of a busy railway tunnel, closing the railway for three days.

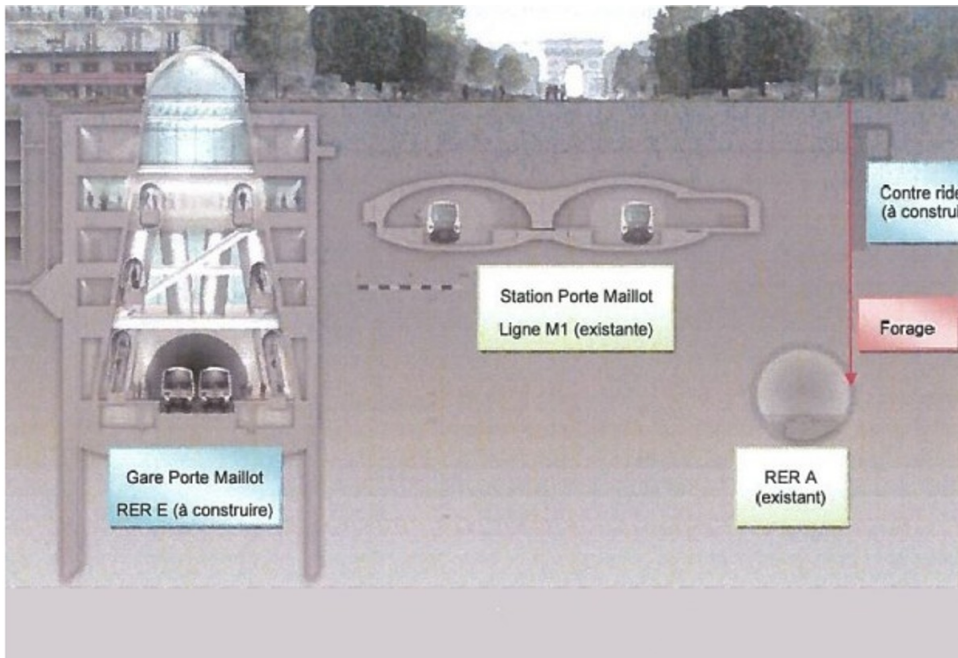
The well was drilled through the water table, and when the drill bit penetrated the railway tunnel, there was an inrush of ground water and mud into the tunnel. Within a few hours, this had reached a volume of 40 cubic metres. The RER A - the busiest urban railway line in Paris - was closed for three days as a result.

- The decision to drill the well was made by the contractors without the approval of the client.
- The positioning of the well was conducted without the control and validation of a surveyor. The official report noted: [translated from the French]

"The lack of intervention of a surveyor resulted in an error which was sufficient to lead to the accident"

- Ensure that appropriate technical and professional advice is sought from surveyors for all operations requiring any type of positioning.
