LTI: Finger injury during pilot ladder preparation

Safety Flash Published on 27 June 2017 Generated on 16 January 2025 IMCA SF 16/17

An Ordinary Seaman was injured while rigging the pilot ladder during arrival in port.

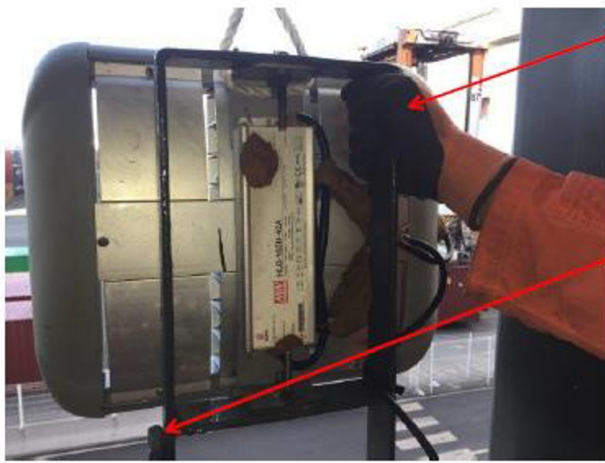
He was holding here with right arm, with gloves, same type as shown, Winter hard protecting gloves

Left hand held here, after removing the pin, the light allowed to swing down, because of severe ambient cold, right hand slipped and lost the hold.
By reflex, used left hand to hold the light from hard hitting down

Left arm finger nail got crushed coming between lamp bracket and ship structure

- Review of specific ship and task risk assessments to include potential risks involved in this operation.
- More effective toolbox talks to be conducted for the crew involved.
- More care to be taken when conducting routine work, especially when less experienced crew are involved.

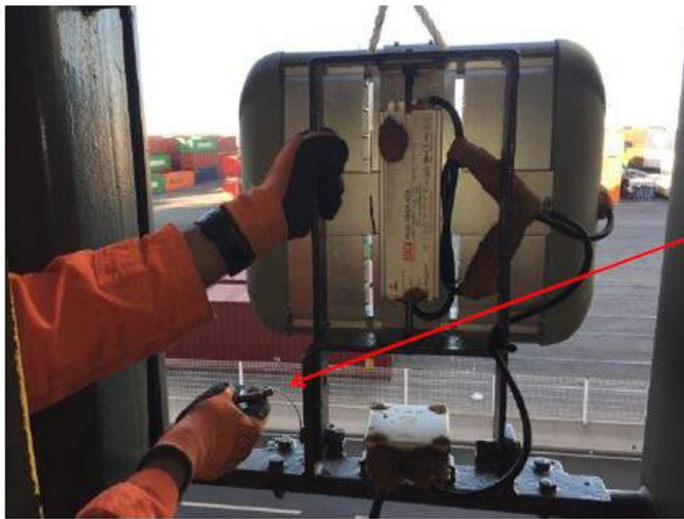
- risk was considered tolerable – this was a routine recurring task
- safety systems were inadequate – there was no properly designed handle to hold the light bracket in place while removing the securing pin.

The Pin securing the light with bracket
