Damage to bulwarks during overboarding of mattresses

Safety Flash Published on 4 July 2022 Generated on 22 January 2025 IMCA SF 16/22

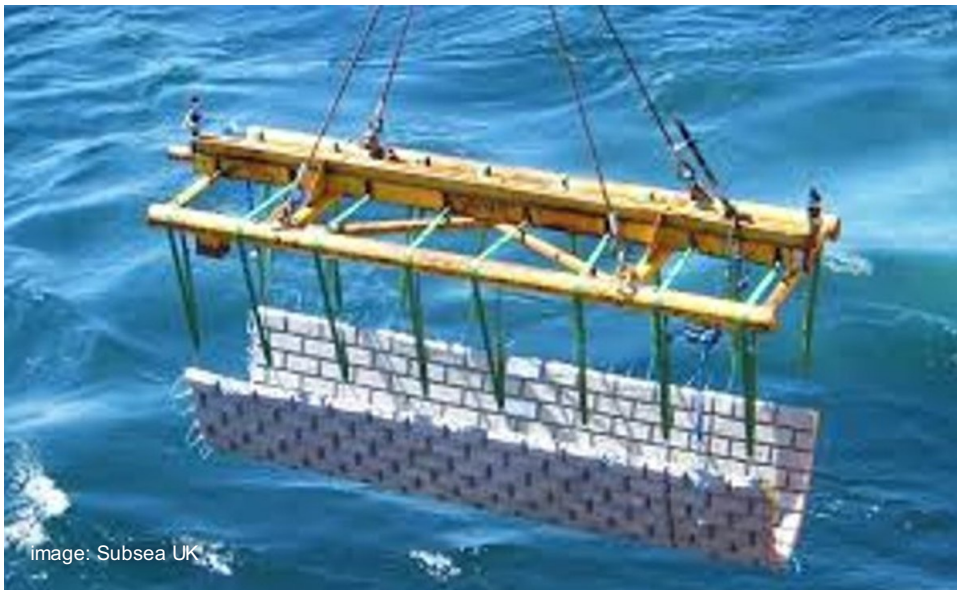
During the overboarding of a mattress stack (3x 150mm mattresses) using a mattress frame, the mattresses made contact with the port side bulwarks causing damage. Before and during the lift, the weather conditions were suitable for the operation.

As the load was lifted outboard, a swell caused vessel motion which led to a pendulum effect on the mattresses. The mattresses then hit the port side bulwarks causing damage. No-one was injured.

The immediate cause of the damage was that the mattress stack made contact with the port side bulwarks during vessel motion due to swell as the load was overboarded.

- Further engagement with deck crews to discuss worksite, crane / task specific challenges or difficulties they face during lifting operations. A series of “Times out for safety” were used to:
 - Present the scenario, explain that everything was done as it should have been.
 - Explain the challenges associated with the lift because of deck / crane design including crane speed and limitations.
 - Discuss anything the teams found challenging – with a view to proactive learning.
 - Record and share as appropriate any concerns, challenges or ideas to improve things.
- Review lift plans and lift planning procedures to ensure prompts are provided to consider the limitations of the crane to be used including speed, line out, route for the lift etc.
