LTI – Struck when anchor wire end pulled free of drum clamps

Safety Flash Published on 4 July 2022 Generated on 23 January 2025 IMCA SF 16/22

A person was seriously injured when he was struck by the end of a 58mm anchor wire.

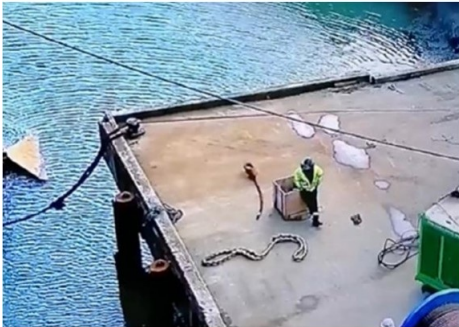
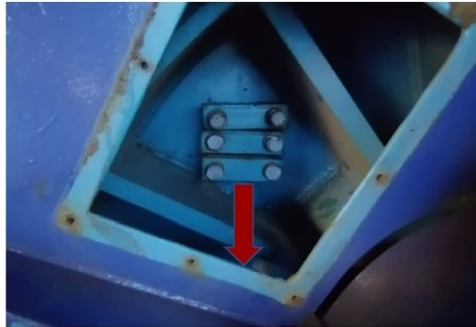
The incident occurred when crew were working on replacing out several 58mm anchor wires. The injured person was walking behind an anchor winch which had a single turn of wire remaining on it. The vessel moved off the quay. Tension came on the wire, which was connected to a spooler ashore. The stoppers in use failed, and the wire end pulled free of the already loosened clamps, whipping over the drum. He was struck across the shoulders/lower neck and suffered several skull fractures when he was pushed into an adjacent bulkhead by the impact, before falling to the deck semi-conscious.

- A generic 'mooring operations' risk assessment was being used. Toolbox Talks had been conducted and documented, but these were based around a clearly inadequate risk assessment (and nobody questioned it during the TBT).
- The stopper arrangement was inadequate. Wires must only ever be stoppered to a suitable strong point using chain stoppers, as detailed in the [Code of safe working practices for merchant seafarers \(COSWP\) 2021](#).
- Safety chains had not been deployed behind the winch. At that stage of the operation, there was a 'Line of Fire' hazard (an alternative route would only have taken about twenty seconds more).
- Insufficient attention was being paid to the tension on the wire by the spooler operators.
- Perceived time pressures and fatigue may also have been factors.

- More thorough planning and more thorough risk assessment would have eliminated most of the several factors which contributed to this incident.
- Adequate time and resources should be allowed in operational plans to allow for effective risk assessment; both vessel crew, project crew and shore-based management have responsibilities in this respect.
