## Crew member in small boat slipped and dislocated shoulder

Safety Flash Published on 1 July 2023 Generated on 23 January 2025 IMCA SF 16/23

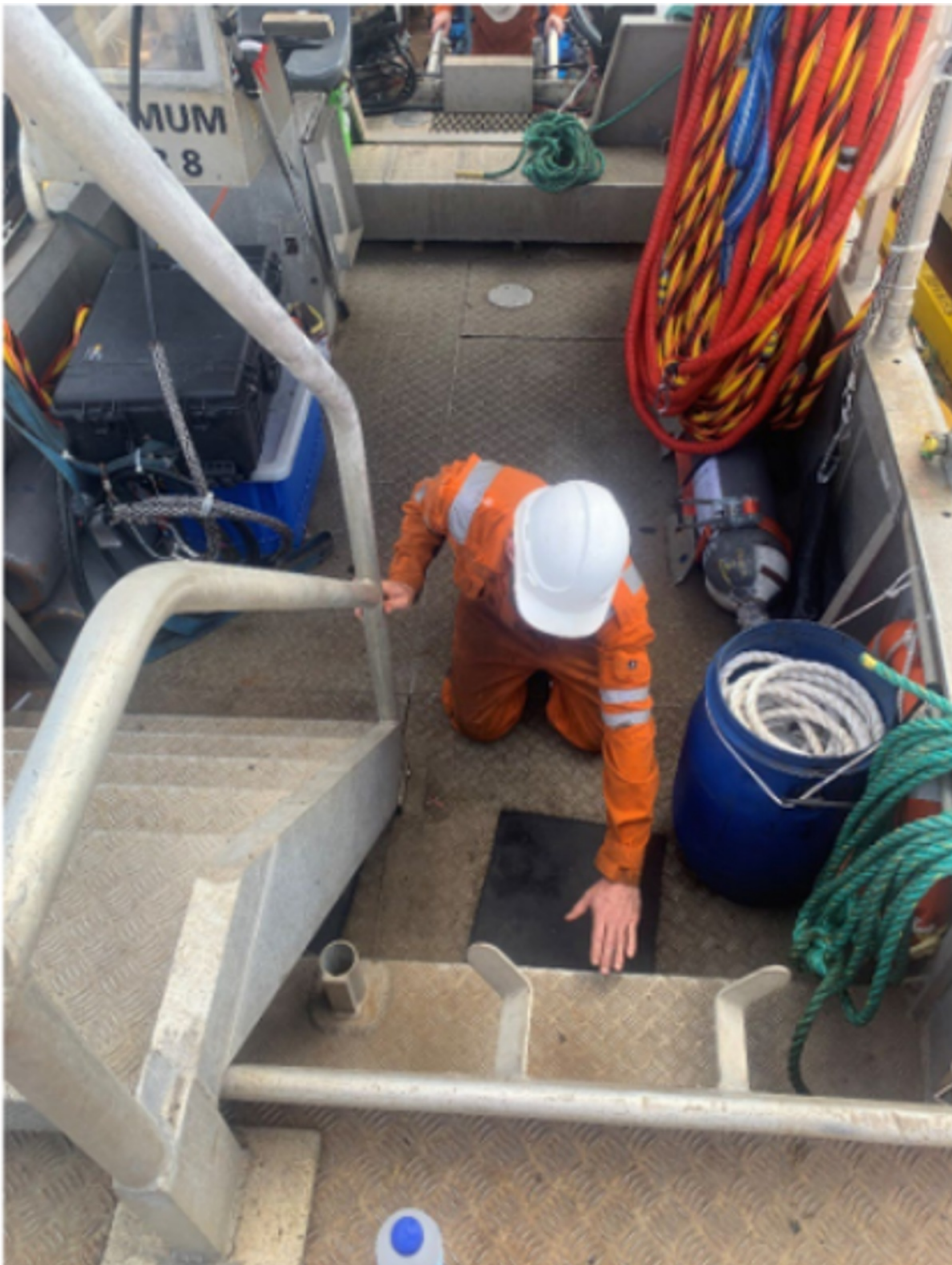
The boat (a small workboat used in diving operations) pitched forward and hit a Catenary Anchor Leg Mooring Buoy. The injured person automatically braced himself by placing a hand on the internal structure of the boat, however the impact on his arm resulted in him getting a dislocated shoulder.

The crew member, whilst he had earlier used some situational awareness to safely re-position himself, had not foreseen the new risks of sudden movement of the boat associated with where he was now working.

Work was now being carried out in a location not covered in the risk assessment. He thought he would be safer, but he wasn't.

- Immediate cause was an unexpected movement of the working environment causing human instinctual behaviour leading to injury.
- Our member found the root causes to be:
  - Risk assessments did not include operational activities being performed in the boat.
  - The requirement for additional equipment being supplied to operational areas and how this was to be undertaken was not adequately addressed within project planning procedures.

- Plan and consider human instinctual behaviour within risk assessments.
  - An example would be when you call someone's name when they're in a space with low headroom, and they automatically look up – and bang their head.
- Look closely at the adequacy of toolbox talks and prestart meetings for small boat work.
