## Failure of lifting padeye

Safety Flash Published on 3 December 2008 Generated on 17 January 2025 IMCA SF 17/08

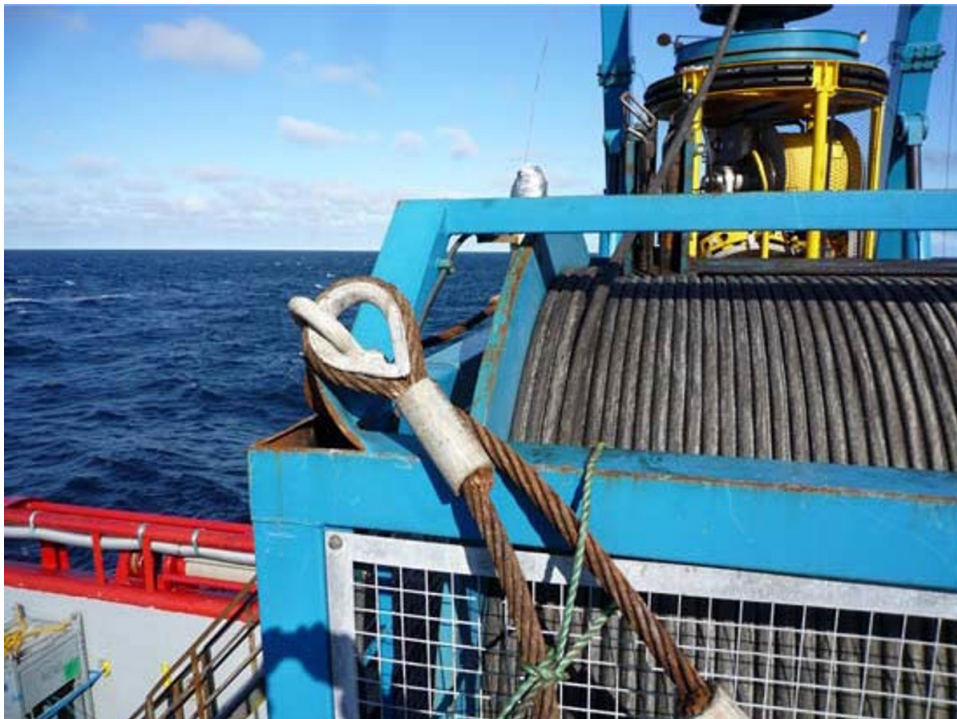
After closer inspection by the ROV pilot technician it became clear that the padeye had peeled away from the box section of the winch.

The cause of the incident is thought to be incorrect design. The 30mm thick padeye is welded directly to the top of a box section made from 5mm thick steel. The load on the padeye goes directly into the unreinforced top surface of the box section. Under repeated loading the padeye had peeled back the top surface of the box section as shown in the photograph.

- Personnel involved in lifting operations must always check the condition of the lifting lugs/padeyes and slings prior to and immediately after use. In this case the damaged padeye was not noticed until some days after the damage was caused.
