## Injury during personnel transfer capsule operation

Safety Flash Published on 1 December 2009 Generated on 12 January 2025 IMCA SF 17/09

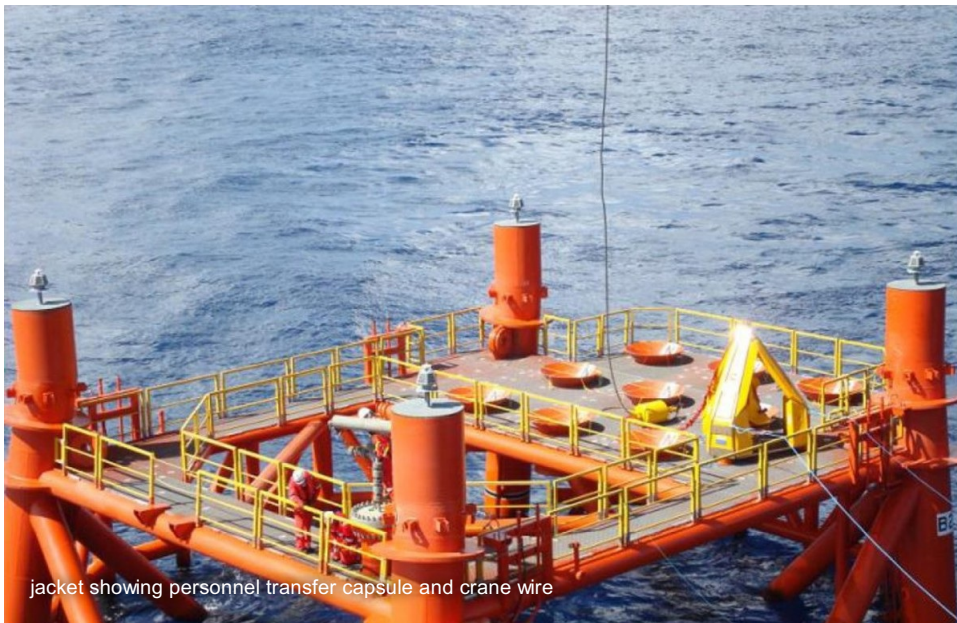
Prior to the actual lift, a swing developed on the crane's headache ball. The swing gathered momentum, despite the efforts of the crane operator to stop it, until it eventually hit one of the platform's legs and ricocheted into the capsule frame. A section of the crane rigging and headache ball hit the frame of the transfer capsule before sliding into the interior of the frame and impacting one of the three occupants.

jacket showing personnel transfer capsule and crane wire

- The size of the area to which the capsule was lowered was not in compliance with the manufacturer's recommendations.
- On this occasion the crane operator did not lay the headache ball down on the jacket during the boarding of the capsule because of worsening swell conditions and restrictions on landing area (see picture).
