Fall from height – LTI

Safety Flash Published on 13 July 2017 Generated on 28 January 2026 IMCA SF 17/17

A supervisor fell through an upper deck hatch on a vessel alongside, suffering injuries that required surgery and physiotherapy and several months away from work.

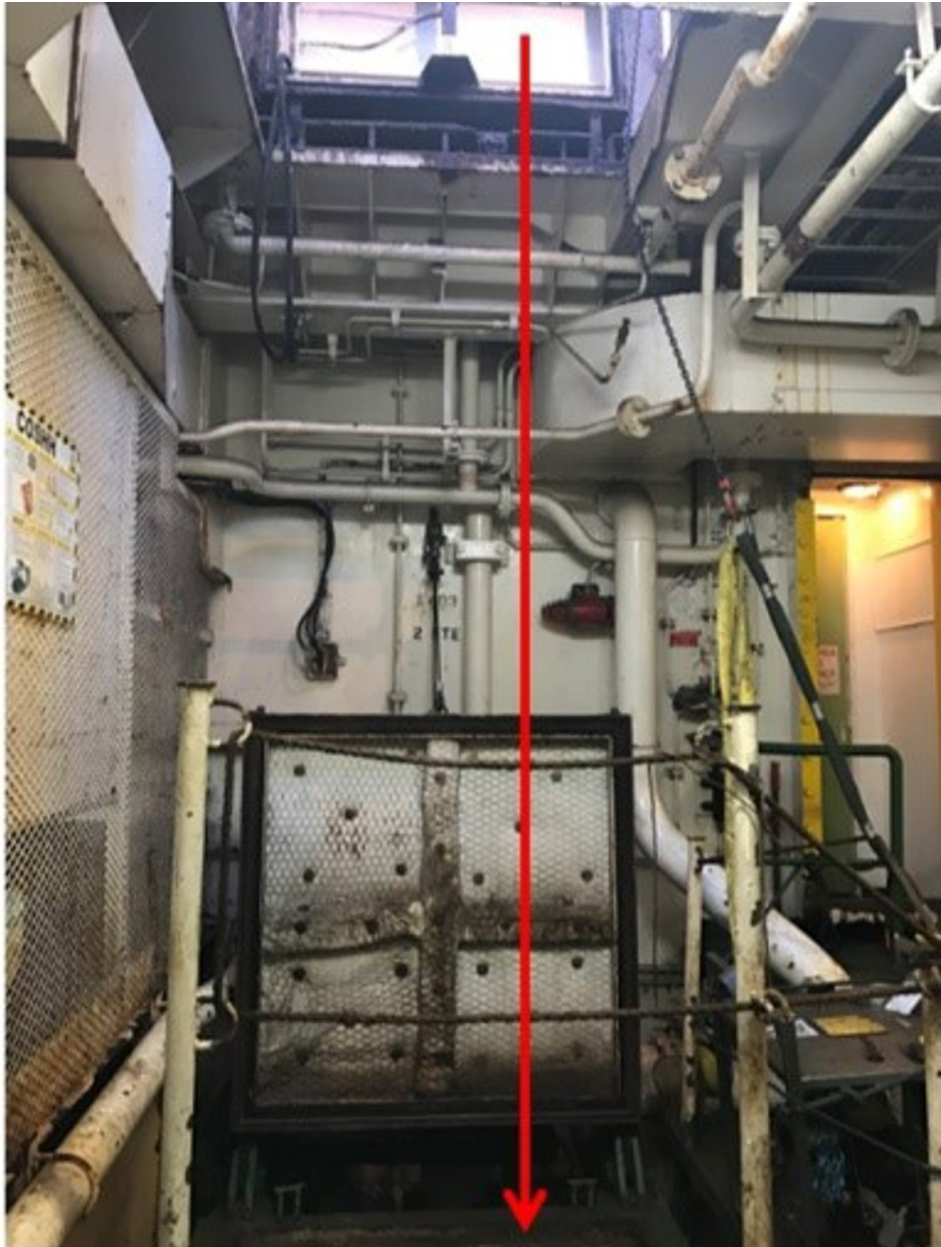
Crew operating the chain pulls were stood inside the barriered off area, wearing fall arrest harness and inertia reel. Their supervisor was on the upper main deck outside of the barriered off area. As the equipment was being lifted using this technique, he moved to get a better look at what was happening. As he did so, he lost his footing and tipped forward toward the portable barrier stanchions and chain, and fell through the barrier and down the hatch.

- Fall prevention barriers that were around the upper main deck hatch were not suitable or sufficient. There was insufficient robust barrier hardware available on board.
- Several trip hazards existed around the area:
 - where the task was being carried out

- where the supervisor was standing
- where the portable barrier was previously positioned – this was also close to the edge of the open upper main deck hatch.
- The supervisor was too close to open hatch hazards without sufficient fall protection.
- Visual obstruction prompted the supervisor to move to get a better look at the activities he was supervising. In so doing he knocked against the portable barrier.
- The supervisor lost his footing/balance close to the edge of the portable barrier and open deck hatches.
- A generic or blanket Permit to Work was used for the recovery/lifting of this equipment using a working at height/chain pull method, rather than a specific Permit to Work.

- Time spent discussing the lift in detail, may have detracted from proper review of the suitability of the existing barrier, and possibly divided attention over risks from the lift versus that from the fall.
- Better management required of Permit to Work system for specific and non-routine tasks.
- A proper review of the barrier previously put in place, and its adequacy to protect against falls versus highlighting a potential trip hazard, seems to have been forgotten during the planning stages of the task.
- Lapses do happen – Comprehensive checklists to confirm specific actions required can help address potential lapses. These checklists could be included in pre-task dynamic/situational assessment, and standard pre-start checks made within the Permit to Work process.
