High potential near miss: unplanned handling of unexploded ordnance

Safety Flash Published on 3 August 2018 Generated on 20 January 2025 IMCA SF 17/18

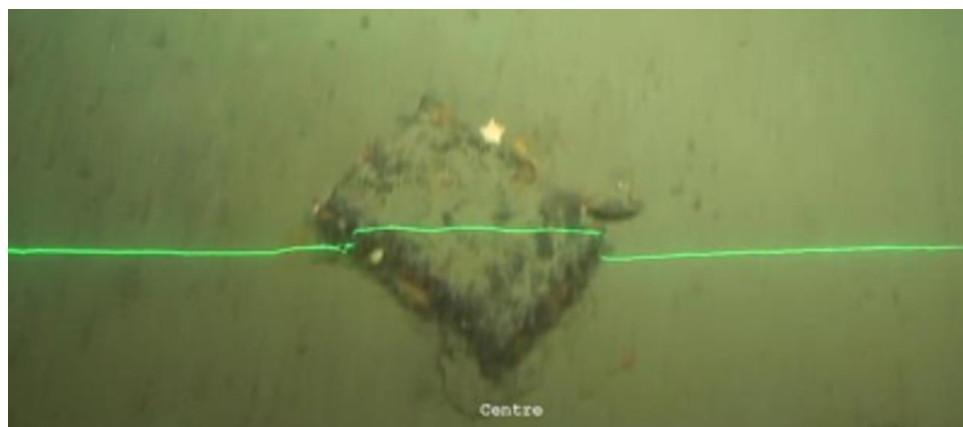
During the initial phases of the operation, several boxes previously classified as concrete debris were investigated and observed to be boxes containing dumped munitions. These boxes were left in place on the seabed. Later in the operation an item recovered, believed to be 'machine parts', was recovered to the vessel deck. The box was handled by vessel crew before they realised it was a WWII munitions box. Expert advice was obtained and the UXO was returned to the seabed.

Investigation determined that the likelihood of an uncontrolled detonation was low. However, since the potential risk at the time of handling was unknown, the situation was defined to be out of control and thus classified as high potential.

- Immediate causes:
 - lack of valid information
 - lack of correct identification of debris
 - lack of management intervention
 - lack of adherence to procedures/lack of direction
 - complacency
- Underlying causes:
 - failure to apply suitable management of change (MoC) and adequately assess risk
 - fundamental misunderstanding of key risks.

- Reinforcement required of stop work authority and MoC, specifically actions towards managers/leaders.
- Revision required for procedures covering actions to be taken in the event of discovering dangerous items such as UXO.
- Method of survey to be re-evaluated.
- Additional training and guidance to teams involved in debris clearance operations.
