Loss of ROV: dropped object

Safety Flash Published on 22 December 2009 Generated on 28 January 2026 IMCA SF 18/09

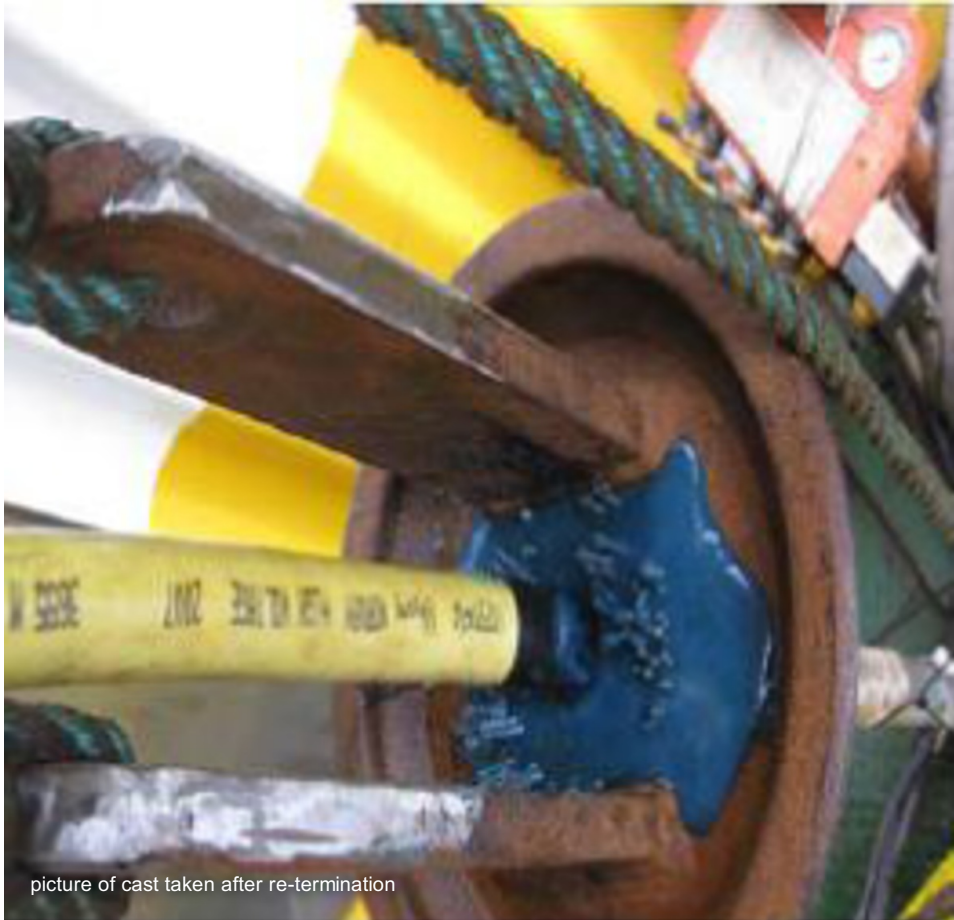
picture of cast taken after re-termination

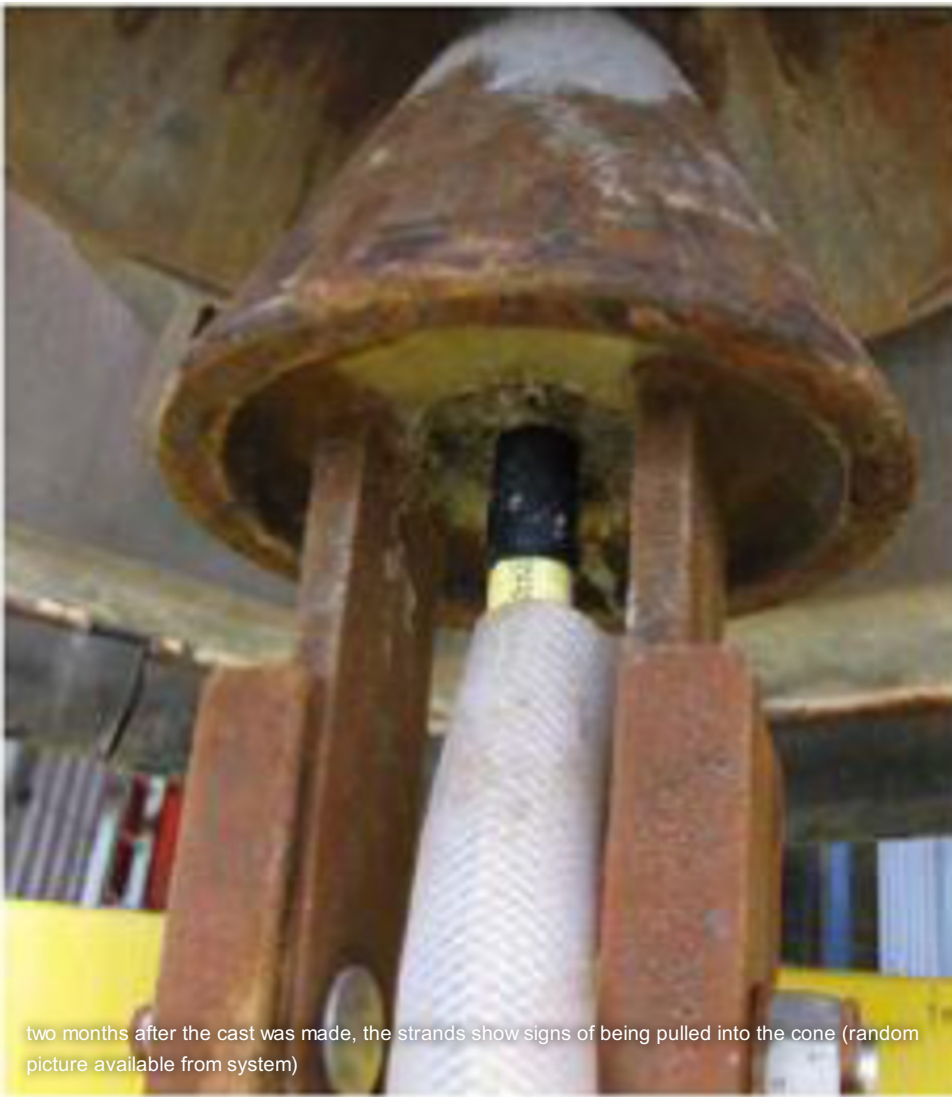
two months after the cast was made, the strands show signs of being pulled into the cone (random picture available from system)

- The friction on the inner wall of the bullet was found to be greater than the combined friction of the strands, with the result that the cast was not able to be drawn down and wedged properly.
- During the investigation it also became clear that the relevant checkpoint in the maintenance programme was not detailed enough.

- Friction on the inner wall of the bullet was greater than the combined friction of the strands.
- An important quality control checkpoint lacked clear, and easy to follow, instructions.

- A new maintenance checkpoint task was added for inspecting the armour strands for any signs of being pulled through the potting.
- Pictures of the cast structure of the company's entire ROV fleet were initiated immediately following this incident, for further review and technical analysis.
- Further pictures of the cast structure of every ROV system would be taken on a frequent basis.
- All bullets made of carbon steel would be changed out and replaced with a new type of bullet made of stainless steel. This would eliminate corrosion and friction to the inner walls of bullet.

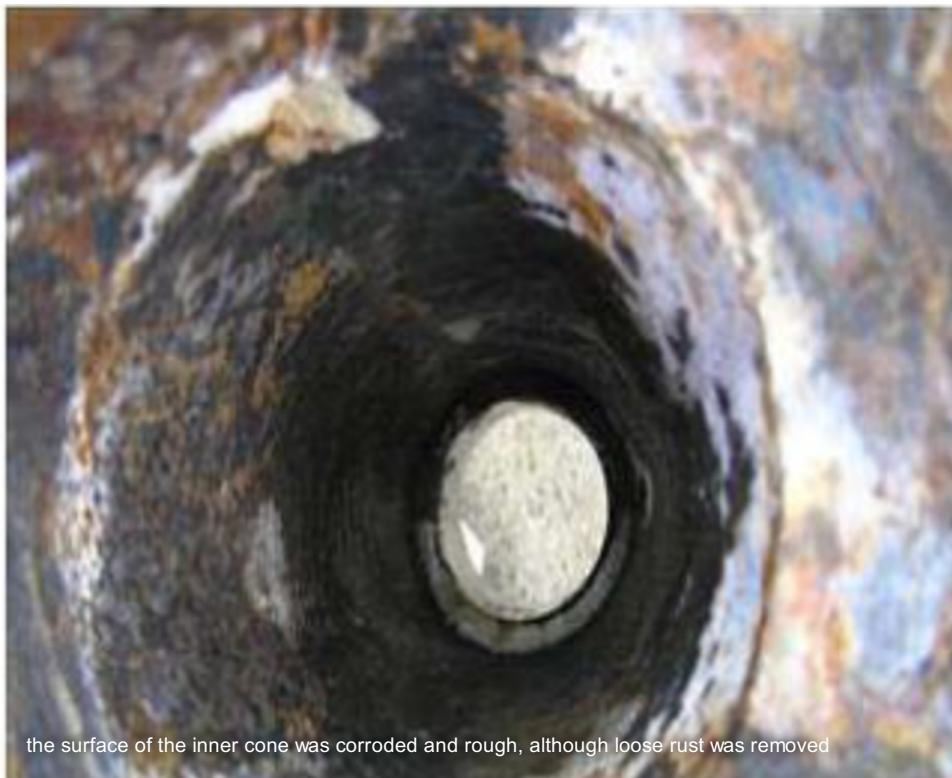
the surface of the inner cone was corroded and rough, although loose rust was removed
