Fatality during lifting operations

Safety Flash Published on 2 December 2002 Generated on 28 January 2026 IMCA SF 11/02

IMCA has been advised of the following fatality which occurred on the pipe deck of an offshore platform.

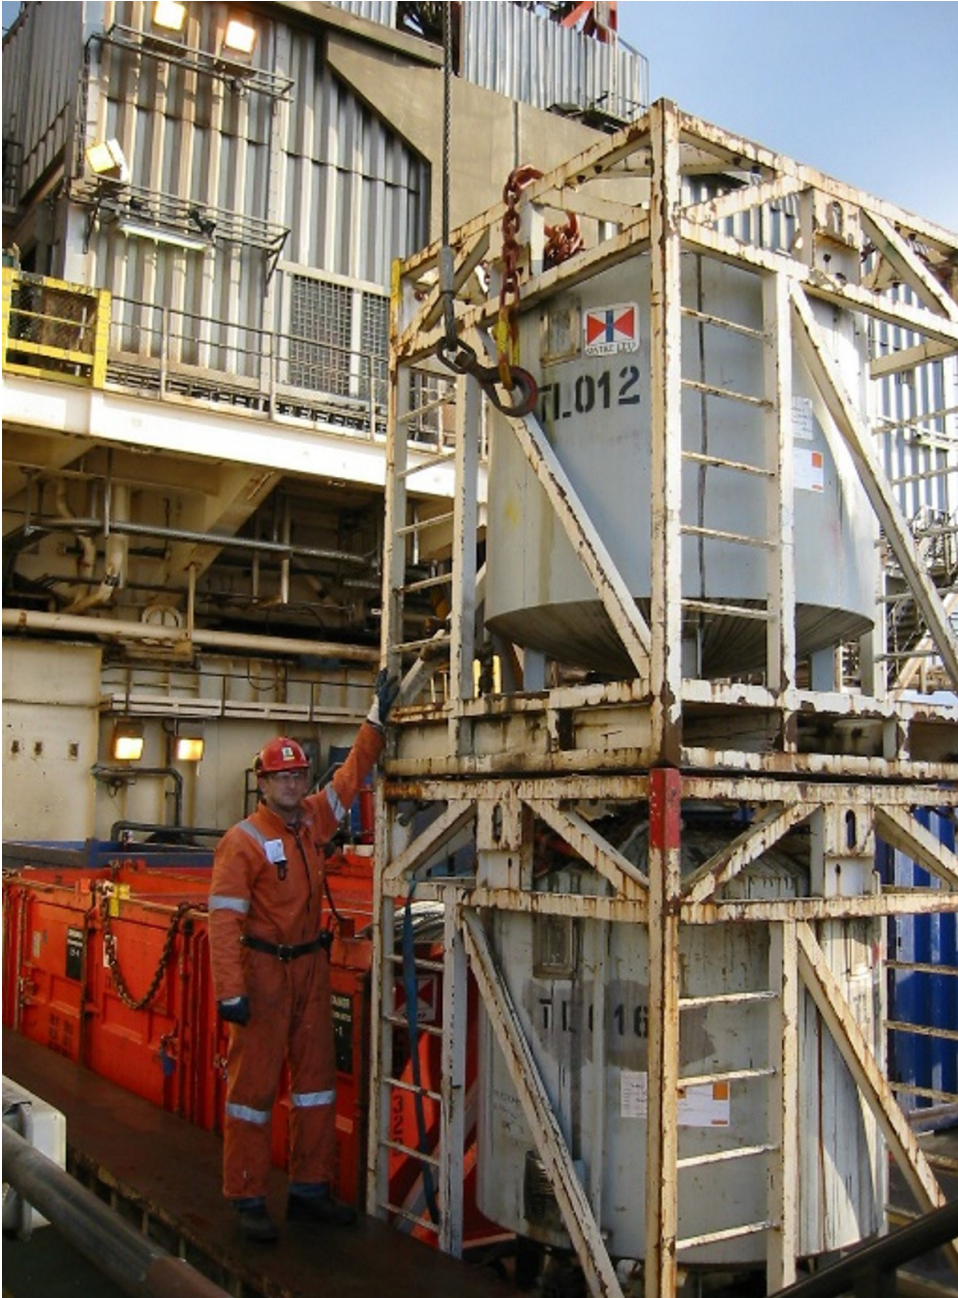
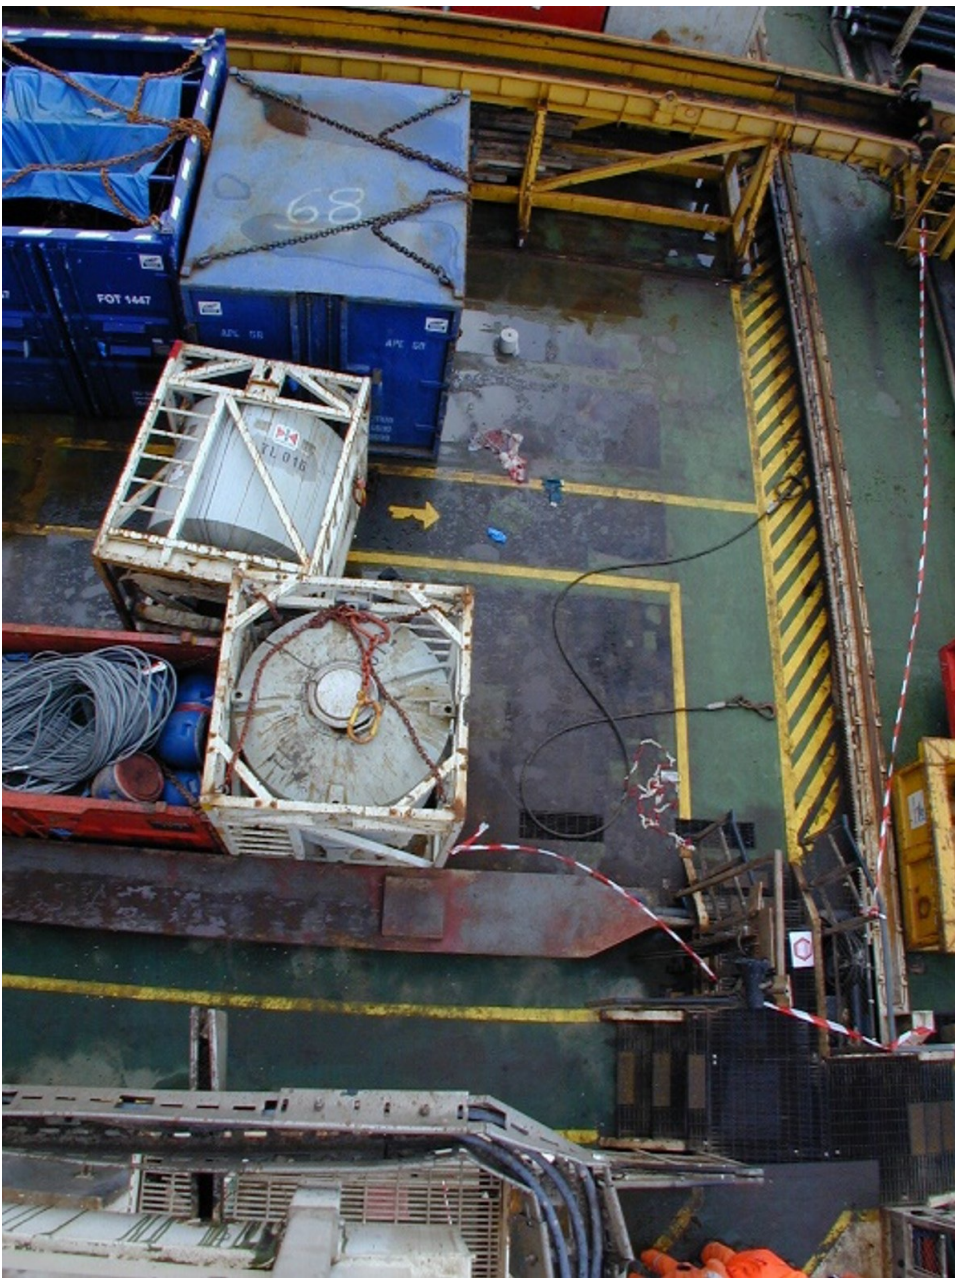
Two chemical pods had been stacked to make room for arriving cargo. To improve overall deck safety, it was decided to unstack the pods during the next shift, since all cargo had arrived and space was available. As this was a 'blind' lift, the crew included two flagmen/hookmen.

One of the hookmen climbed up the integrated ladder on the side of the pods, in order to hook the chain sling. During this operation, the crane pendant was lowered too much and went inside the frame holding the pod. When the hookman told the crane driver to lift up approximately 20cm, the pendant snagged the frame and lifted one end of the pod. As soon as one side of the tank had cleared the stacking lugs, the tank started to slide.

The hookman had his upper body above the frame and, when the tank toppled, his chest was crushed between the falling pod and an adjacent container, stored approximately 2.6 metres from the pods. The injuries to his chest were fatal and death was immediate.

1. Inadequate design: the pods were designed for stacking, but the lugs did not properly prevent sliding if subject to external forces (e.g. crane, container). The chain slings were also too short to allow hooking from deck level, which had been required in the company's procedure for stacking to be allowed.
2. Inadequate planning and worksite walk-through: the safest way to perform the task had not been identified (the chain sling was hanging down the opposite side and there was no need to climb on top of the pod).
3. Inadequate identification of job hazards: working at heights (4.6 metres at the top of the upper pod) and not recognising the potential hazard of a trapped pendant.
4. Inadequate communication: the flagman could not see the top of the tank and

hence could not direct the lowering of the crane pendant; the hookman was carrying out multiple tasks, including communication with the crane driver.

1. Stacking of these pods and others of similar design to be banned by the company; consideration to be given to banning all stacking of containers.
2. A pocket-sized aide-mémoire card to be introduced by the company, to prompt and aid appropriate prior assessment of lifts.
3. Existing company rules on working at heights to be properly enforced (working on a ladder above 2 m height was already a violation of company rules).
4. Company rules on lifting to be clarified/changed:
 1. 'hooking at deck level' means standing on the deck itself.

2. flagman to be the only person communicating with the crane drive; flagman not to touch load; flagman to be identifiable by wearing a bright vest.
