# Safety Flash

## **Fatality during lifting operations**

Safety Flash Published on 20 December 2013 Generated on 3 July 2025 IMCA SF 18/13

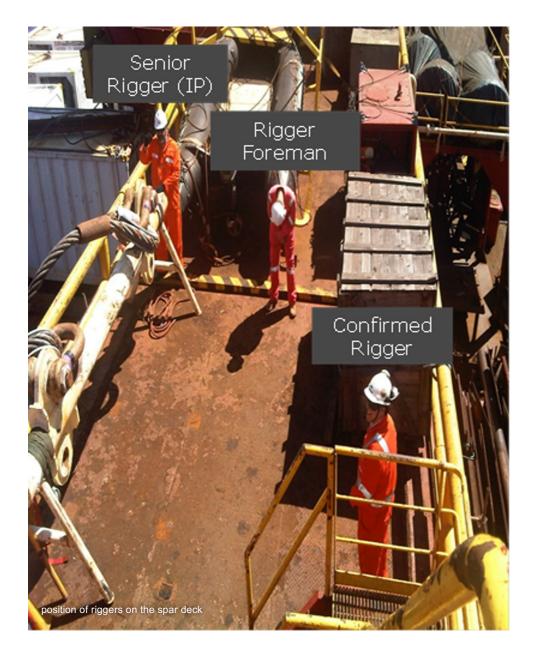
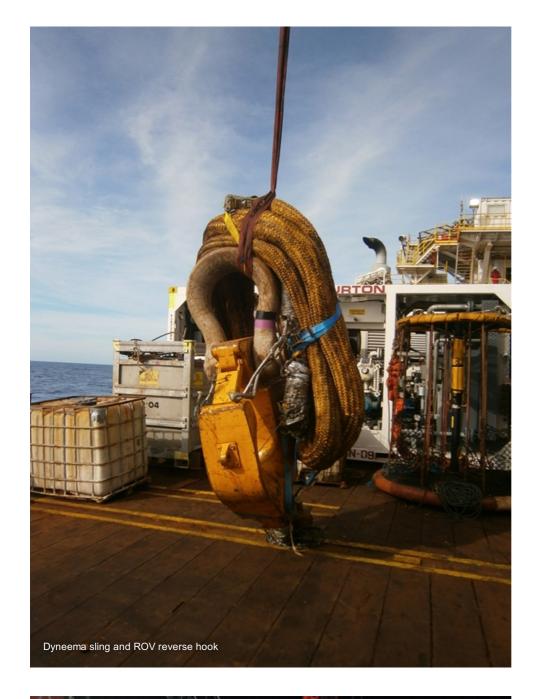
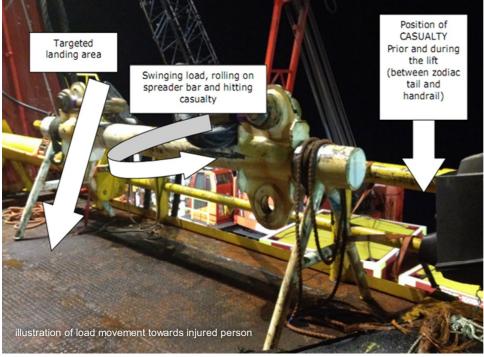
After confirmation was given to send the load it arrived suddenly at the spar deck; it landed inboard against the spreader. It then slid forward towards the senior rigger, who was struck twice by the suspended load. Due to his height the load made contact with his chest and crushed him against the cargo rail, at his back.

- · Incident occurred in daylight hours.
- Wind was 20-22 knots ESE.
- Significant wave height 2.7 m, with maximum wave height of 3.1 m.
- The senior rigger may have felt he was already in a safe position, between the end of the spreader bar and the stern of the zodiac, not anticipated he was actually at risk.
- The slide forwards of the heavy load may have been caused by:
  - o induced momentum from crane swing
  - o contact with the parking leg of the spreader beam
  - o contact with the lifting eye, nubbins of spreader beam
  - o induced spin from offset of centre of gravity
  - o vessel motion from sea state, or
  - o any combination of the above factors.

- Careful consideration should be given to all lifting operations. All lifts require planning whether they are 'routine' or non-'routine'.
- Careful consideration should be given to the positioning of personnel particularly riggers and banksmen, during lifting operations;
