High potential near-miss: Incompatible pillar valve assembly

Safety Flash Published on 20 December 2013 Generated on 25 April 2025 IMCA SF 18/13

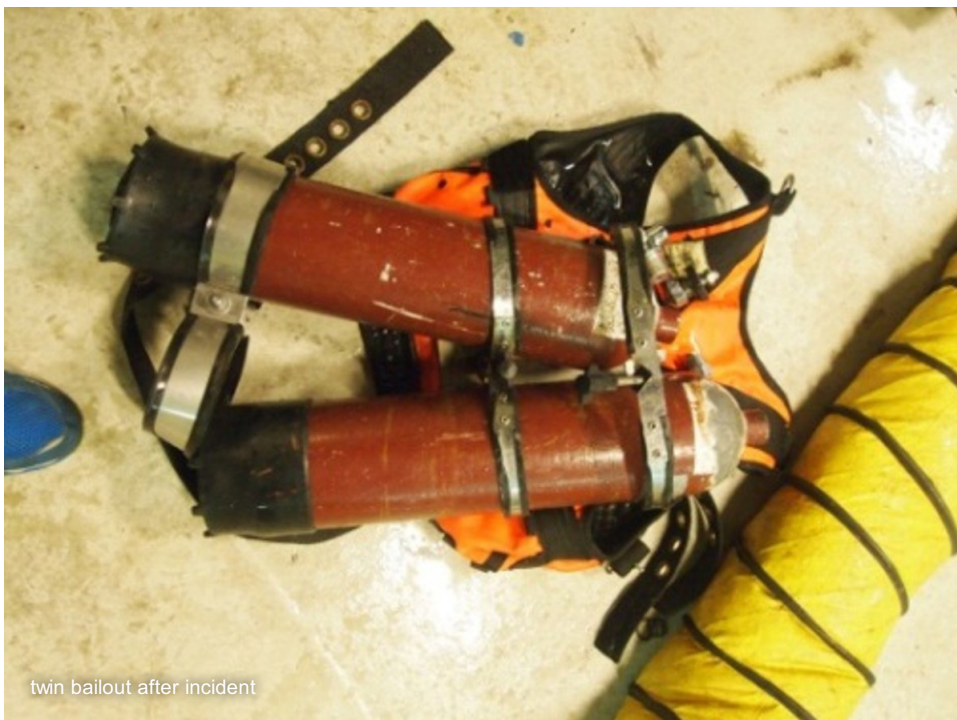
A small leak was detected at the charging whip connection to the bailout. This resulted in the repositioning of the bailout in the charge tank, so that the twin bailout set was submerged. This action was undertaken to assist in the cooling of the twin bailout and in the detection of leaks. Within less than two minutes there was a loud explosion/release of gas from the charging tank. The gas supplied was immediately isolated. Upon inspection it was identified that the pillar valve failed to hold the content of the cylinder.

twin bailout after incident

- Different types of cylinders (imperial and metric) were being used on the same job site.
- There was no management of change (MOC) process undertaken, to change pillar valve to twin manifold configuration.
- Additional force was applied to insert new pillar valve (no inspection undertaken as to why there was a resistance).

- Replacing bailout cylinders with metric only.
- Vessel technicians to be supplied with a precision measuring instrument (for measurement of thread patterns).
- Training to be undertaken by dive team / project department pertaining to the use of MOC.
- Implement system that ensures only metric thread cylinders and components used.
- Marking of all metric and imperial parts and cylinders to be undertaken for ease of identification.
