## Master link failure during testing of overboarding chute

Safety Flash Published on 25 November 2014 Generated on 28 January 2026 IMCA SF 18/14

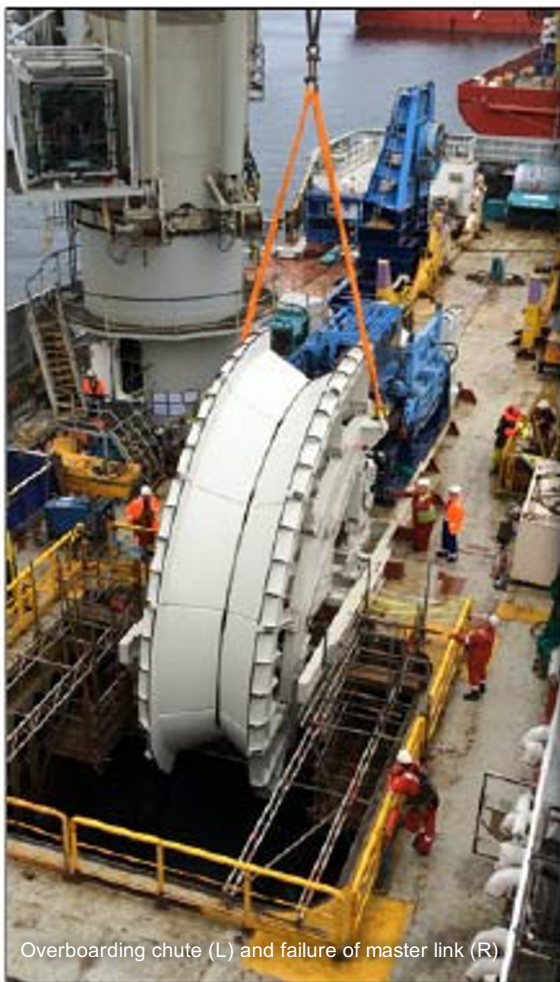
The chute sustained damage in several areas to the extent that it and the deployment spread had to be demobilised from the vessel. No-one was injured but the potential existed for a person to be struck by the failed master link as it fell to deck.

- Whilst the immediate causes of the incident contributed to the failure of the master link, the root cause was attributed to a failure to develop and apply an effective safe system of work.

- The requirement to closely monitor the load was not recognised.
- Analysis of the failed master link identified defects that could have caused failure below MBL. The process of establishing the cause of the defects was ongoing.

- Reviewed all master links onboard; quarantined any William Hackett 38.3Te master link with batch number H678/1-8.
- Management/Supervisory personnel to discuss alert with their teams and reinforce expectation that anyone can request further or challenge information that may compromise the safety of the task; . Recognise the potential risks associated with moving loads that are attached to the deck (or similar) as part of reviews, and ensure an appropriate level of detail in procedures, lift plans and risk assessments accordingly.
