## Parting of hawser and bulk cargo hose during tandem mooring

Safety Flash Published on 25 July 2017 Generated on 17 January 2025 IMCA SF 18/17

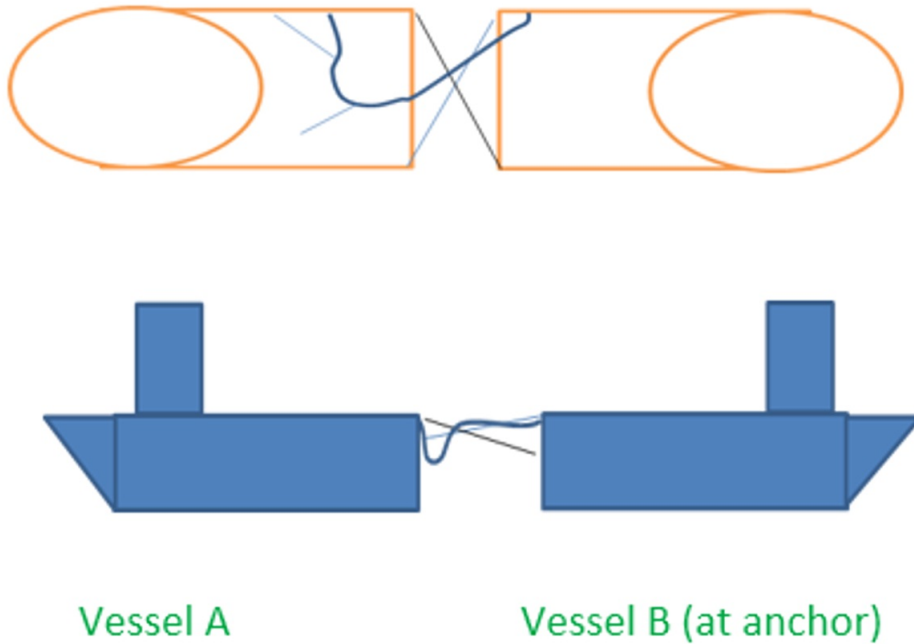
The mooring rope from Vessel A parted due to jerking and continuous yawing. Crew on Vessel B were told to close the deck fuel valve and disconnect the hose for retrieval. The hose was disconnected and crew on Vessel A started retrieval using the port tugger winch. While they were retrieving the hose, it got entangled with the remaining single mooring rope and the vessel structure, and the hose parted on deck. No spillage was noticed as hose was empty.

- There were 1.5m seas and wind of approx. 14 knots. Both vessels were yawing – the mooring ropes was getting intermittent jerks which resulted in one of them parting. The uncontrolled heaving of the bulk cargo hose resulted in it parting.
- Both vessels could have decided to call off or postpone the operation until the fuel pump was operational and/or weather would improve.
