## Crane anti-two block securing wire failure

Safety Flash Published on 25 July 2019 Generated on 16 January 2025 IMCA SF 18/19

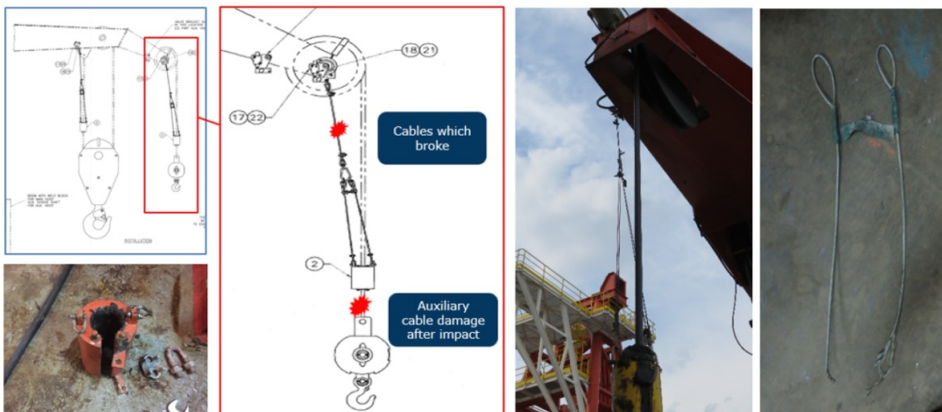
- During inspection and function test of the A2B system, the actuation lever was found seized.
- Testing and inspection had not been carried out in accordance with equipment operating instructions.
- The crane operator's daily checklist noted 'testing' of the A2B system. However, it was found that only visual inspections were performed.
- The upper A2B suspension wires had parted at a position and in a fashion which suggested that the wires were severed by contact with the crane sheave and/or auxiliary wire. It is probable that the seized actuation lever prevented the A2B system from functioning correctly, allowing the crane block to pay-in past the 'cut off point', causing slack in the suspension wires and contact with the sheave.

A2B weight assembly

Crane auxiliary A2B system and components involved

Crane auxiliary A2B system near the sheave

Parted A2B suspension wires

- Full and thorough inspection of crane A2B systems to confirm that they are maintained, functioning correctly and free of potential seizing (of the actuation level).
- Inspection of equipment holdbacks/retention wires to identify potential for slack and/or entanglement with moving parts. Consider replacing wires with larger diameter.
- Always comply with equipment pre-start checklist requirements, including function testing of equipment where specified.
- Inspections should be appropriately documented to record subsequent findings/corrective actions, and records reviewed appropriately on a regular basis to verify effectiveness.
