## MAIB: vessel collision caused by mismatch between bridge and engine room control

Safety Flash Published on 3 September 2024 Generated on 24 January 2025 IMCA SF 18/24

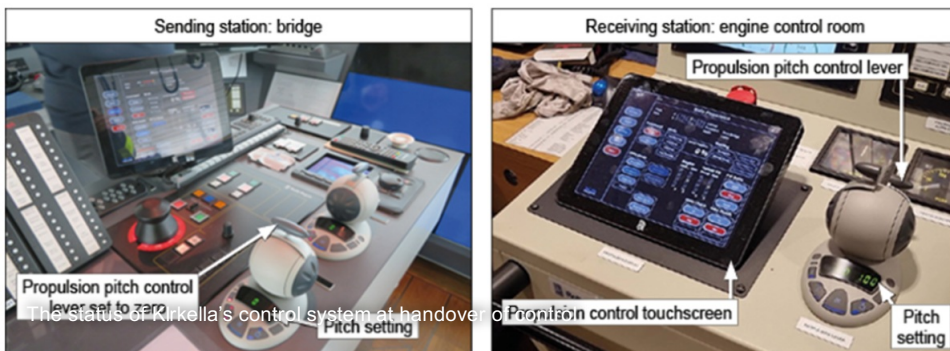
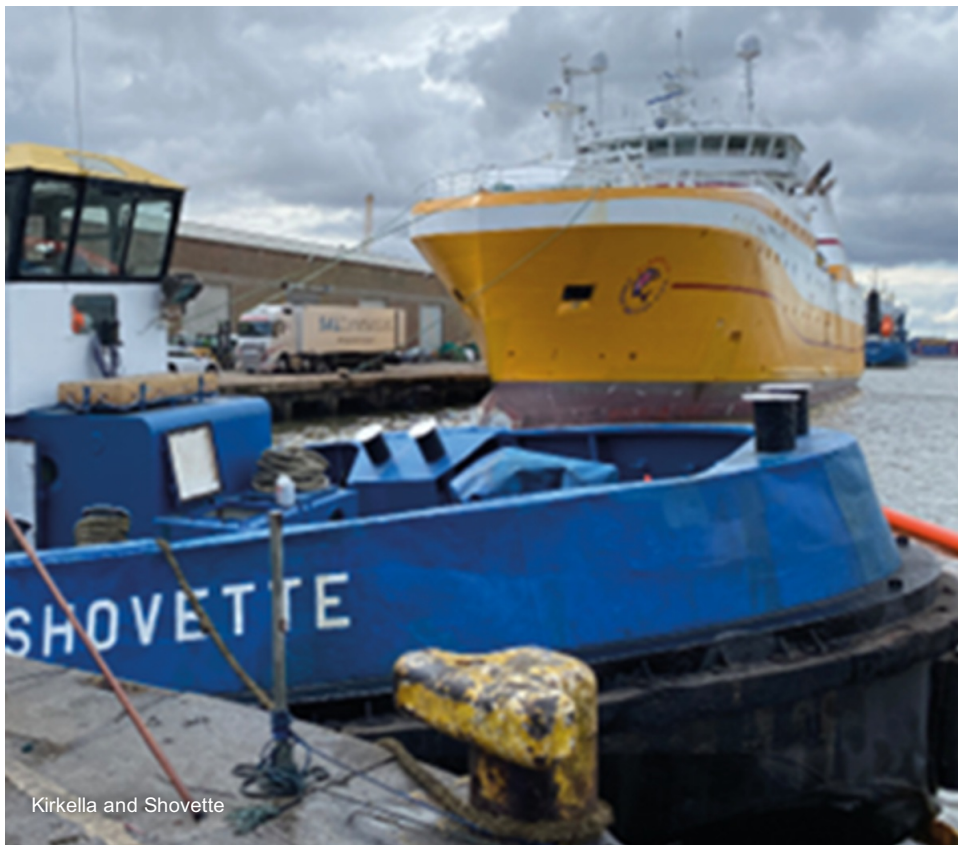
Fishing vessel *Kirkella* lost control of its propulsion system while berthing, and collided with the harbour tug *Shovette* in the port of Hull, UK. *Kirkella*'s bulbous bow breached *Shovette*'s hull and starboard fuel tank during the collision, causing the tug to partially sink and resulting in approximately 7,000 litres of marine diesel oil spilling into the dock. *Kirkella* was not damaged. There were no injuries.

*Kirkella*'s propulsion system comprised a single main engine driving a controllable pitch propeller via a clutch and gearbox. The propulsion system could be operated from several stations located in the wheelhouse and from the engine control room (ECR). **The loss of control occurred when the propulsion control was passed from the bridge to the ECR with the clutch engaged.** At the time of the handover, the bridge propeller pitch lever was set at zero, while the ECR's propeller pitch lever was set at 100% ahead. The propeller pitch automatically advanced when control was accepted in the ECR, causing *Kirkella* to move forward on the berth.

Kirkella and Shovette

- The pitch levers for *Kirkella's* propulsion control system were not synchronised between the bridge and engine control room when control was transferred. The propulsion control system was not fitted with interlocks to prevent this from happening – these were not required.
- *Kirkella's* engineer had not checked that the engine room pitch lever was matched to the bridge pitch setting when control was passed from the bridge to the engine room.
- There was no procedure for control changeover.

- The interlocks, which were optional, could be retrofitted by the engine manufacturer.
- Robust shipboard practices are essential to maintain propulsion control during handover, regardless of whether system interlocks are fitted. Documented procedures should contain a requirement for the operator of the sending station and the receiving station to check that propulsion systems pitch settings are synchronised at the time of transfer.
- To reduce the risk of propulsion thrust being applied inadvertently while alongside the MAIB suggests that it is advisable to declutch engines before transfer of control.
