## Rigging incident: Damage to bow hand rail on a crew transfer vessel (CTV)

Safety Flash Published on 23 November 2015 Generated on 21 January 2025 IMCA SF 19/15

A member has reported an incident in which the bow rail of an offshore renewables crew transfer vessel was damaged.

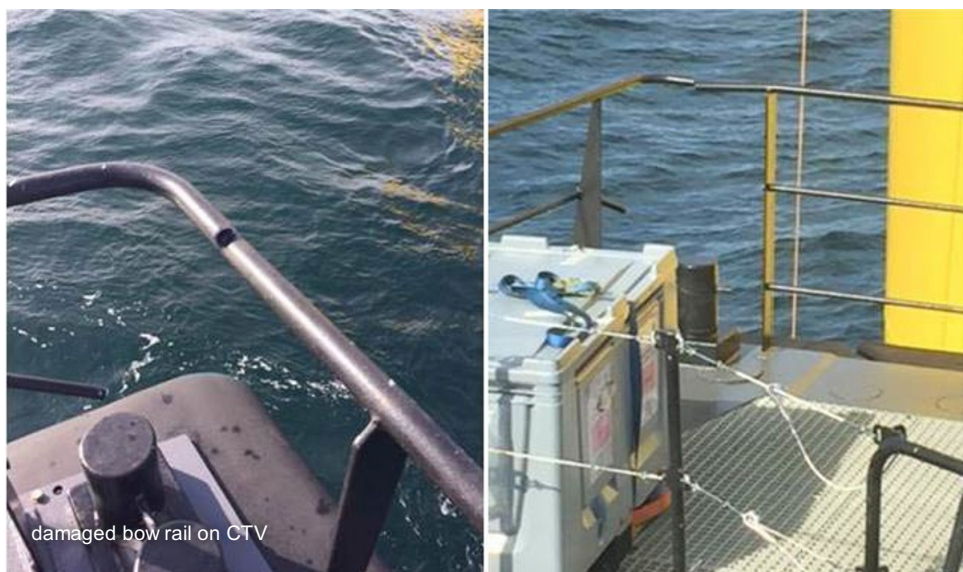
Unknown to the Master, as his vision was very restricted with a large grey storage box on the foredeck, the riggers had pulled the line over the top rail and made fast to the bollard below. The rope drew tight and personnel positioned themselves away from the bow to avoid the snap back zone. The rope did not snap but it cut through the top rail and broke the middle rail off completely.

damaged bow rail on CTV

- A toolbox talk had been held on-board, including the Master and superintendent before the work took place, and at no point was it discussed that the line would be tied to the forward cleat.
- The incident was discussed on-board after its occurrence and it was highlighted that in the event of snagging, the line should never be tied to the vessel and nothing should ever be tied over the handrails.
- The handrail was repaired on the next maintenance day.

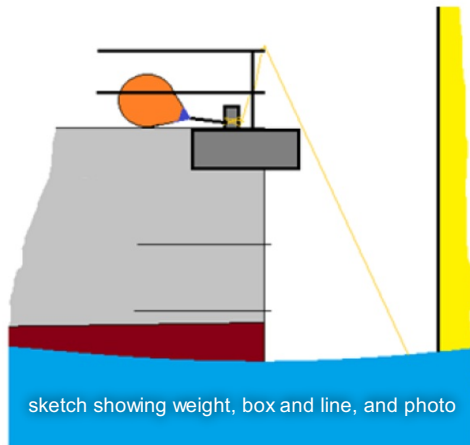
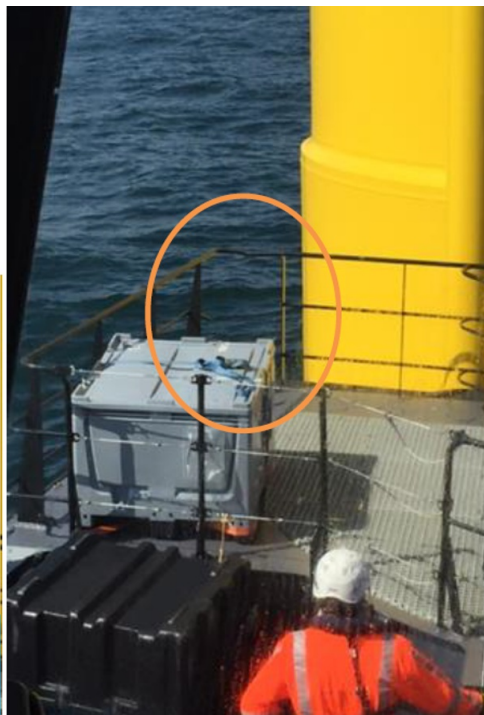
Sketch showing weight/buoy/line:

The incident occurred whilst retrieving a buoy and clump weight on the seabed next to a wind turbine generator monopile. The line attached to the weight snagged, damaging the vessel's bow railing. Crew were on the foredeck retrieving a buoy from the monopile (attached to a clump weight of 15-20 kg which was on the seabed).

Once the buoy had been lifted on-board, two riggers quickly began retrieving the loose line until it became taut against the weight on the seabed. As they began to pull the weight up from the seabed it became snagged. The riggers fixed the line to the forward cleat so that they could reposition themselves to pull harder.
