LTI: Crush injury to middle and index finger

Safety Flash Published on 2 August 2017 Generated on 24 January 2025 IMCA SF 19/17

Riggers on a vessel were moving heavy deck plates (2.45 m x 1.2 m x 5 mm, weighing 114 kg) when one of them got his hand caught, causing a crush injury.

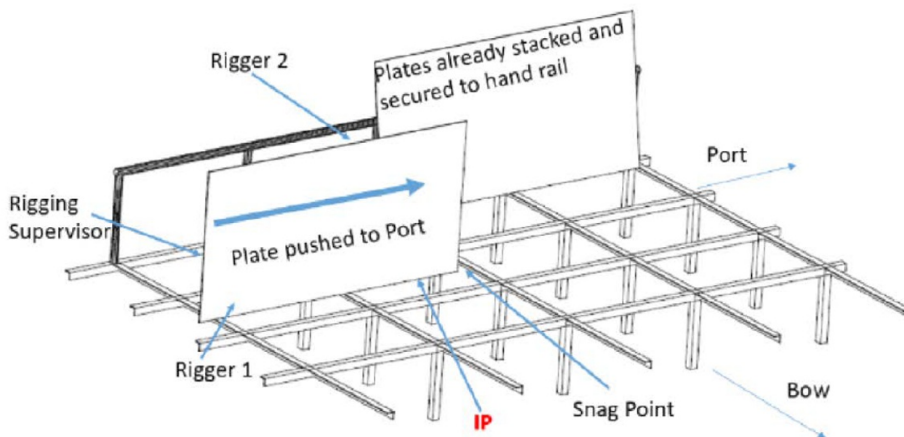
While moving one of the plates and turning it through 90° onto its long axis, to be slid over the angle beam foundation, the leading corner of the plate caught on a section of angle beam and stopped sliding. A rigger (the IP in the sketch below) attempted to rectify this by lifting the corner, enabling the rest of the team to push the deck plate. Upon setting down the deck plate, his middle and index finger became trapped between the angle beam foundation and the deck plate, causing a serious injury.

- The incident occurred as a result of 'scope creep'. There was no proper Management of Change.
- The size and weight of the deck plates did not allow for a safe and ergonomically friendly means of moving them, especially over the angle beam foundation.

- The injured person placed his hand beneath the deck plate despite being instructed not to do so by his supervisor.
- The injured person was wearing welding gloves, rather than the impact gloves required in the JRA (job risk analysis).
- Pinch points had been discussed in a task-specific toolbox talk held just before starting the job.

- The change of job scope ('scope creep') should have triggered a stop, leading to the change being properly managed. A new permit should have been raised with a task specific JRA.
- Members may wish to use this example to highlight the issue of 'scope creep' and appropriate Management of Change – particularly where manual handling is involved.
