Third-party truck not in appropriate or safe condition

Safety Flash Published on 26 July 2022 Generated on 28 January 2026 IMCA SF 19/22

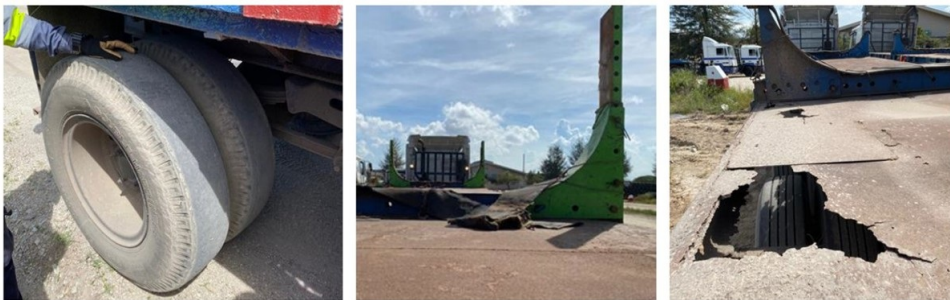
Photo

Trucks to be used for the pipes were inspected and several defects identified.

- Unsafe tyres (low tread levels).
- Expired vehicle registration certificate displayed on trucks.
- Heavily corroded trailer beds, including holes on surface.
- Rubber padding was found worn and detached from bolsters.

- Fuel gauge not working.
- Missing side mirrors.
- Sagging wheel fenders, contacting tyres.

A planned inspection of trucks was performed jointly by the coating supplier and company site representative as part of the preparation activities. Several defects across multiple trucks were identified. The supplier was instructed to remove the trucks from service until all defects were rectified.

- Clearly define requirements and expectations relating to use of trucks with applicable 3rd parties. This should include truck condition/roadworthiness, required safety features, driver qualifications and competence, fatigue management and route planning.
- Consider adopting a specific truck inspection checklist to be used by the site team.
- Company site representative to participate in truck inspection activities and is authorised to reject any trucks considered unfit for purpose.
