## Fatal diver incident due to uncontrolled differential pressure

Safety Flash Published on 2 August 2016 Generated on 28 January 2026 IMCA SF 20/16

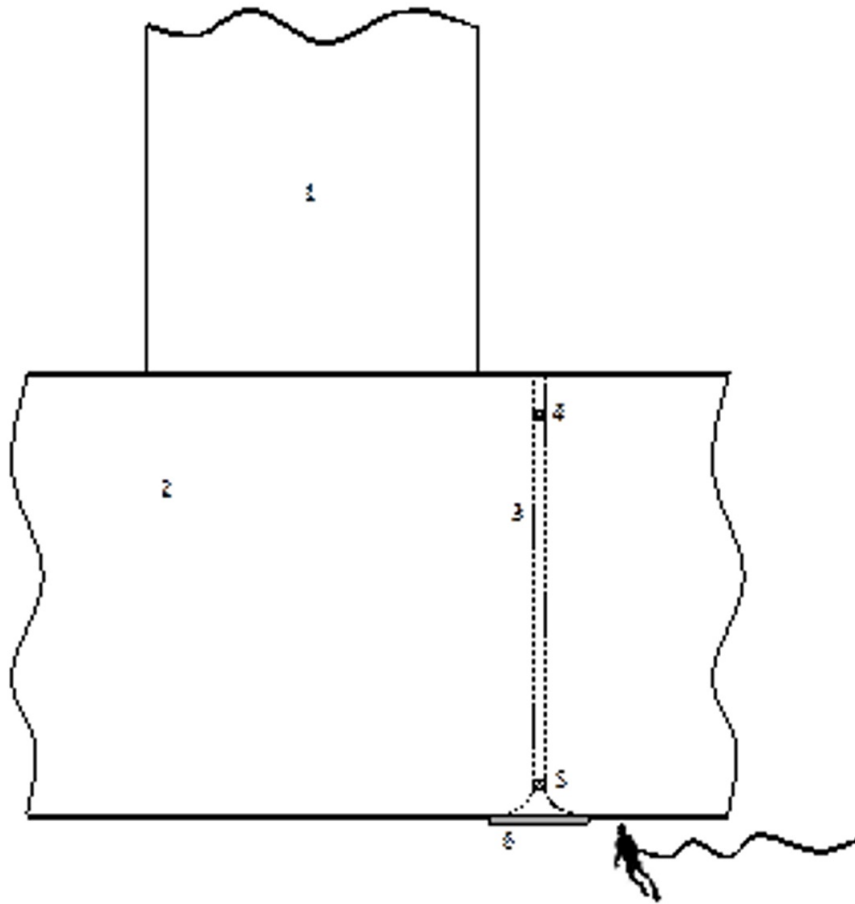
Figure 1. Schematic drawing of worksite.

1. The column going up to the top of the rig
2. The port fwd side of the port pontoon
3. The torpedo pipe
4. The upper valve, approx. 1.2 m from top of pontoon
5. The lower valve, approx. 1m up from flat bottom
6. Cover used to seal the lower opening of the pipe

When the diver introduced air into the pipe an artificial, undiscovered concrete plug on top of the upper valve broke and the divers head and left arm were sucked into the pipe causing great pain. The standby diver, being fully dressed, entered the water immediately (within 30 seconds) and the wounded diver was brought to the surface within 9 minutes. At the time he had stopped breathing, but his breathing and pulse were regained through CPR. The diver was sent to hospital where he died two days later.

This fatal diving incident was due to uncontrolled differential pressure.
