## Near-miss: Unintentional release of diving helmet – neck dam/helmet securing arrangements

Safety Flash Published on 2 August 2016 Generated on 14 January 2025 IMCA SF 20/16

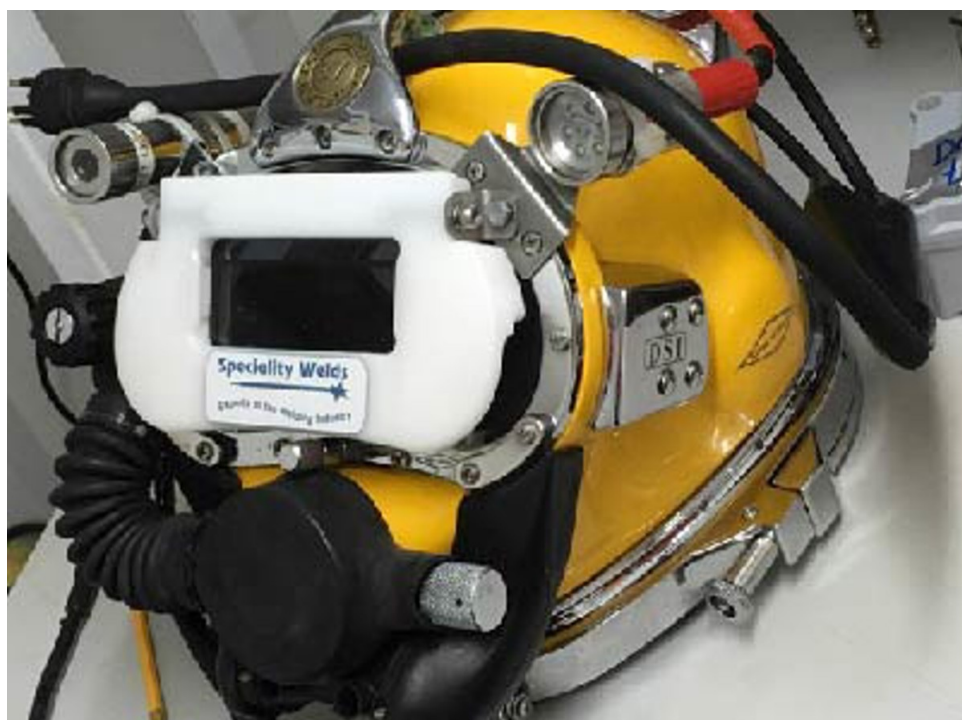
The incident occurred in 9m water and there was minor water ingress into the helmet. The diver maintained vertical position, activated his free-flow and was recovered to the surface safely. The hat did not flood and communications between the diver and supervisor were maintained throughout. On his safe arrival to the surface, he was examined immediately by the on board doctor and pronounced well.

- Immediately after the incident the helmet was quarantined and inspected by qualified personnel.
- The helmet appeared to have no defects, structural damage or other identifiable issues which may have caused or contributed to the separation.
- Separation occurred via the mechanism designed for releasing the helmet from the neck dam.
- The certification of this particular helmet was valid in accordance with company standards.
- Pre-dive checks were logged and reported with video evidence available of them occurring.
- The investigation team concluded with the information available to them that the root cause of failure was human error. It appears that the tender did not fit the hat correctly to the diver during pre-dive checks.

- Divers pre-water entry 'call out' list to be repeated a second time and signed off by the diver's tender and a competent second person.
- Helmet lock pins should be fitted with approved Kirby Morgan sleeves as an additional control.
- Duties and responsibilities for all personnel should be made clearly known by tool box talk on a 'dive by dive' basis, i.e. each person is to know his exact emergency location in the event of a diving related in water emergency.
- In this case, owing to the distance between the diving launch and recovery systems, a swim line was placed between the two to allow the emergency/standby diver easier and quicker access to any stricken diver.
- Training around the risk of complacency should continue.
