## Near-miss: Unintentional release of diving helmet – neck dam/helmet securing arrangements

Safety Flash Published on 2 August 2016 Generated on 28 January 2026 IMCA SF 20/16

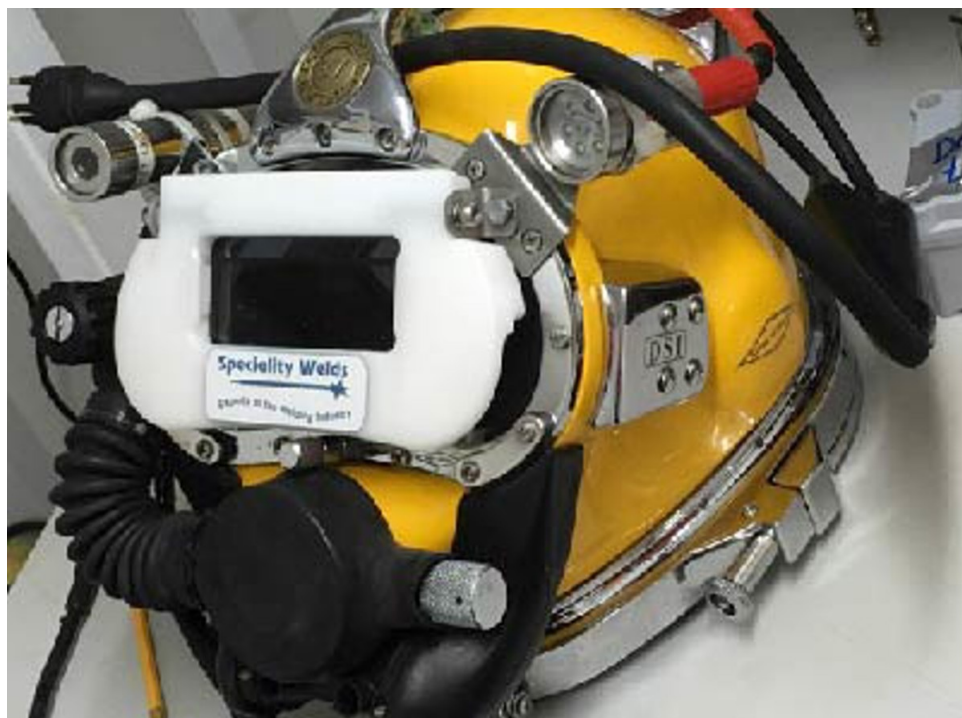
The incident occurred in 9m water and there was minor water ingress into the helmet. The diver maintained vertical position, activated his free-flow and was recovered to the surface safely. The hat did not flood and communications between the diver and supervisor were maintained throughout. On his safe arrival to the surface, he was examined immediately by the on board doctor and pronounced well.

- Immediately after the incident the helmet was quarantined and inspected by qualified personnel.
- The helmet appeared to have no defects, structural damage or other identifiable issues which may have caused or contributed to the separation.
- Separation occurred via the mechanism designed for releasing the helmet from the neck dam.
- The certification of this particular helmet was valid in accordance with company standards.
- Pre-dive checks were logged and reported with video evidence available of them occurring.
- The investigation team concluded with the information available to them that the root cause of failure was human error. It appears that the tender did not fit the hat correctly to the diver during pre-dive checks.

- Divers pre-water entry 'call out' list to be repeated a second time and signed off by the diver's tender and a competent second person.
- Helmet lock pins should be fitted with approved Kirby Morgan sleeves as an additional control.
- Duties and responsibilities for all personnel should be made clearly known by tool box talk on a 'dive by dive' basis, i.e. each person is to know his exact emergency location in the event of a diving related in water emergency.
- In this case, owing to the distance between the diving launch and recovery systems, a swim line was placed between the two to allow the emergency/standby diver easier and quicker access to any stricken diver.
- Training around the risk of complacency should continue.
