High potential near miss: failure of valve on gas bottle

Safety Flash Published on 11 August 2017 Generated on 23 January 2025 IMCA SF 20/17

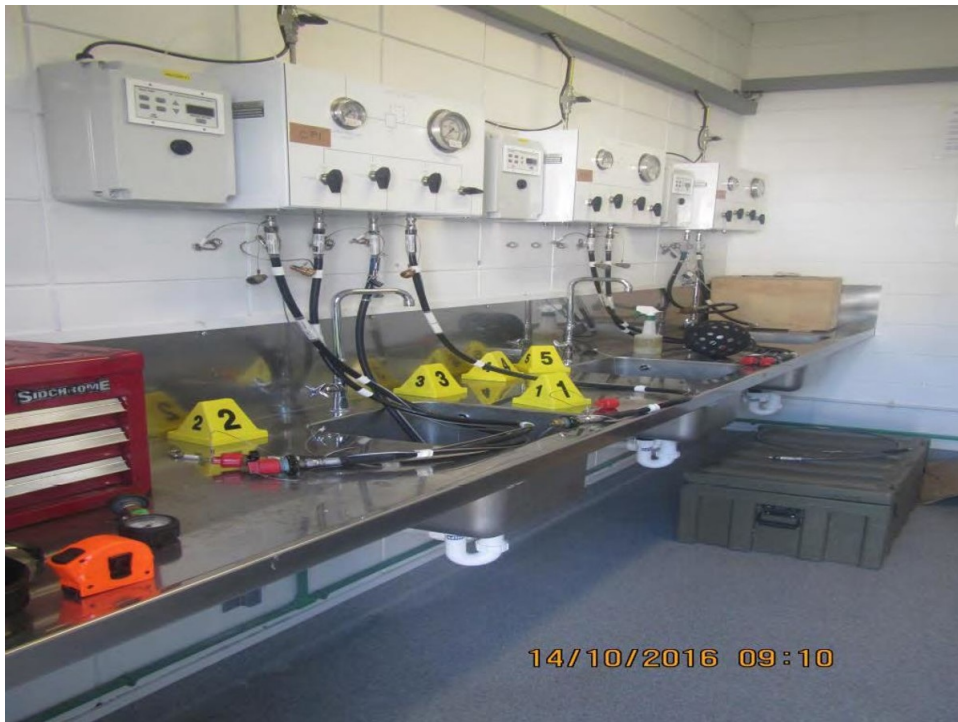
Though the filling components had been correctly connected, one of the bottle valves has failed and was violently expelled from the high pressure (HP) cylinder. As a result of the failure, the charging whip and valve remnant had forcefully impacted a nearby wall. Had these parts hit the crewman the consequences could have been very much more serious.

- The valve failure was mechanical in nature; a metallurgical failure of the integrity of the valve assembly, rather than being due to the process of filling the flask. Analysis determined that a combination of corrosion induced cracking

and fatigue in the dipper tube thread roots lay at the heart of the failure.

- The exact cause of the corrosion could not be identified; however, the presence of dezincification and small particles of Verdigris in the cracks suggested that insufficient rinsing, after the 24-monthly application of mildly acidic BIOX cleaning compound, was the most probable cause.
- The level of Verdigris and the lack of oxygen caps and written emergency procedures show a need for further development of management systems.
- There was a post incident procedural failure, in that the person involved was not checked by a medic. Despite this he does not appear to have suffered any lasting detrimental effects as a result of the incident.

- All similar valves of a similar age have been removed from service and replaced with new.
- Appropriate record-keeping measures were put in place for controlling the age of valves in use.
- A new method of securing filling arrester whips to cylinder necks was devised to prevent the potential thrashing around of loose whips under pressure.
- A review was made of procedures for valve oxygen cleanliness to ensure they meet the minimum internationally recommended standards.
- Recommendation was made that local regulations associated with the acquisition, introduction into service, on-going maintenance, marking and establishing a defined maximum operational life of valves used in association with HP cylinders, should be amended to reflect the lessons identified in this incident.
- Consider further development of training course for persons involved in filling HP cylinders.
