Dropped object: first aid injury during ROV maintenance

Safety Flash Published on 10 September 2018 Generated on 28 January 2026 IMCA SF 20/18

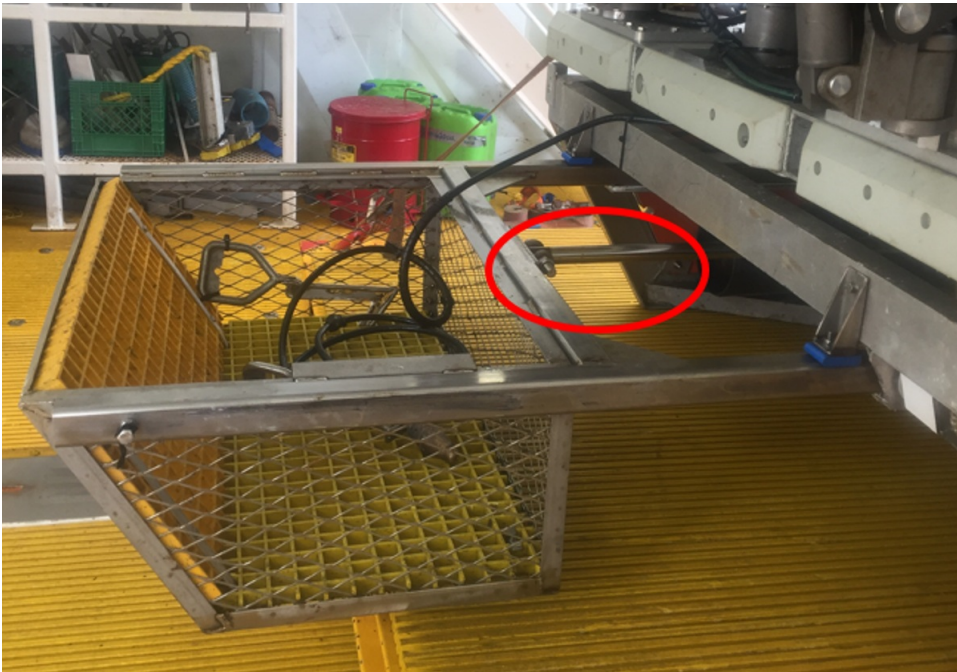
A tooling tray guide arm fell from an ROV skid rail slot and hit an ROV technician's torso.

He was beneath the ROV disconnecting the securing pin. Two further technicians had pulled out the tooling tray to allow access for the injured person to clear himself from underneath. While doing so, the guide arm dropped from the ROV skid rail onto the ROV technician underneath. The estimated weight of the tooling tray was 68 Kg. He was taken to the local clinic as a precaution for a check-up, as the vessel was in port at the time of the incident.

- There was a requirement to remove the tooling tray before the next project.
- The technician was required to go underneath to disconnect the securing pin from the hydraulic cylinder that connects the tooling tray to the ROV skid.
- The skid was removed whilst he was underneath, and it fell onto him causing injury.
- The risk assessment performed was not task specific.

- There was a lack of communication and poor risk perception demonstrated by the ROV technicians.
- The mechanism was not designed to be easily or safely removed.

- There is a need for the attachment design for the clevis pin to be in a position that allows for access from the main deck in front of the ROV, removing the need for personnel to be underneath during removal.
- There needs to be higher hazard/risk perception for routine tasks.

- Improved the design (see image) eliminating the need for working underneath.
