Two serious dropped object near miss

Safety Flash Published on 10 September 2018 Generated on 28 January 2026 IMCA SF 20/18

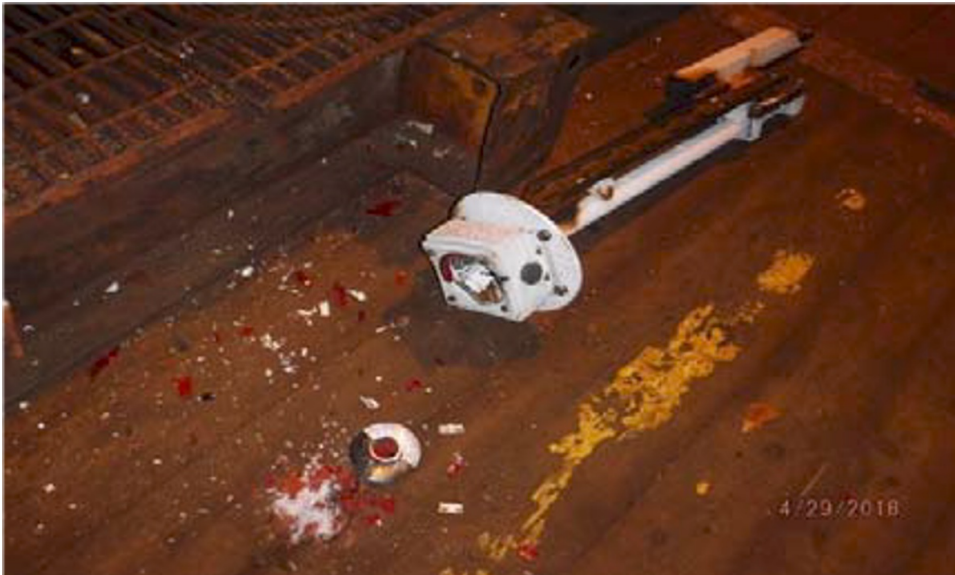
Incident 1

A light and fitting on a third-party ship, weighing 8kg, fell 20 metres to the deck narrowly missing one of the crew members. The light was fitted to a post which had previously been identified as heavily corroded.

The corroded item had previously been identified by the ship owners, but no corrective action was taken to secure the light and remedy the situation. Subsequent inspection by our member identified other items at risk of falling.

- Outstanding defects that pose a risk of dropped objects should be categorised as dangerous and either removed or rectified.
- Worksite management should ensure that only the correct secured tools are used when working at height.
- Tools used at height should be fitted with the appropriate securing devices to prevent them falling.
- Ensure that all work at height is subject to a specific risk assessment which addresses the potential for dropped tools and work equipment, and identifies the controls to prevent this happening.
- Barriers under towers should be set at a sufficient distance considering the possibility of items deflecting off any structures.

- Prior to third-party vessels being taken on hire, evidence should be produced by the owner to prove that there has been a DROPS survey conducted, and a regime is in place to inspect, maintain and correct any defects affecting the security of equipment at height.

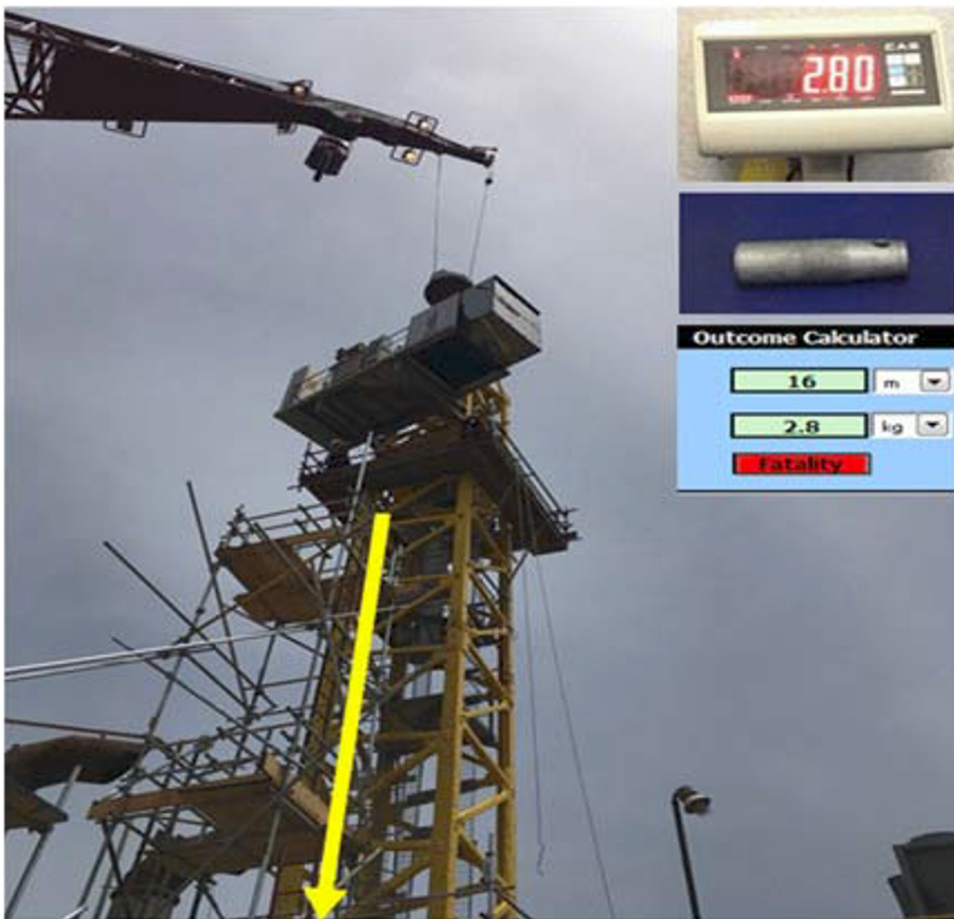
Incident 2

A 2.8kg steel pin fell 16 metres to the deck. The area immediately below the drop area had barriers set, however if the pin had hit the structure and was deflected it could have endangered the deck crew.

Findings: the task was not planned, or risk assessed correctly:

- The removed pin was placed on the tower structure instead of in a scaffold clamp type basket.
- The rigger was unfamiliar with the task and was not made aware of the required rules when working at height.
- Tools in use by the work team did not have the required lanyards and could have also fallen to the deck.
