LTI – Person fractured pelvis in a fall from a ladder

Safety Flash Published on 15 August 2023 Generated on 23 January 2025 IMCA SF 20/23

A crew person suffered a fractured pelvis falling 4-5 metres from a temporary access ladder onboard a cargo vessel.

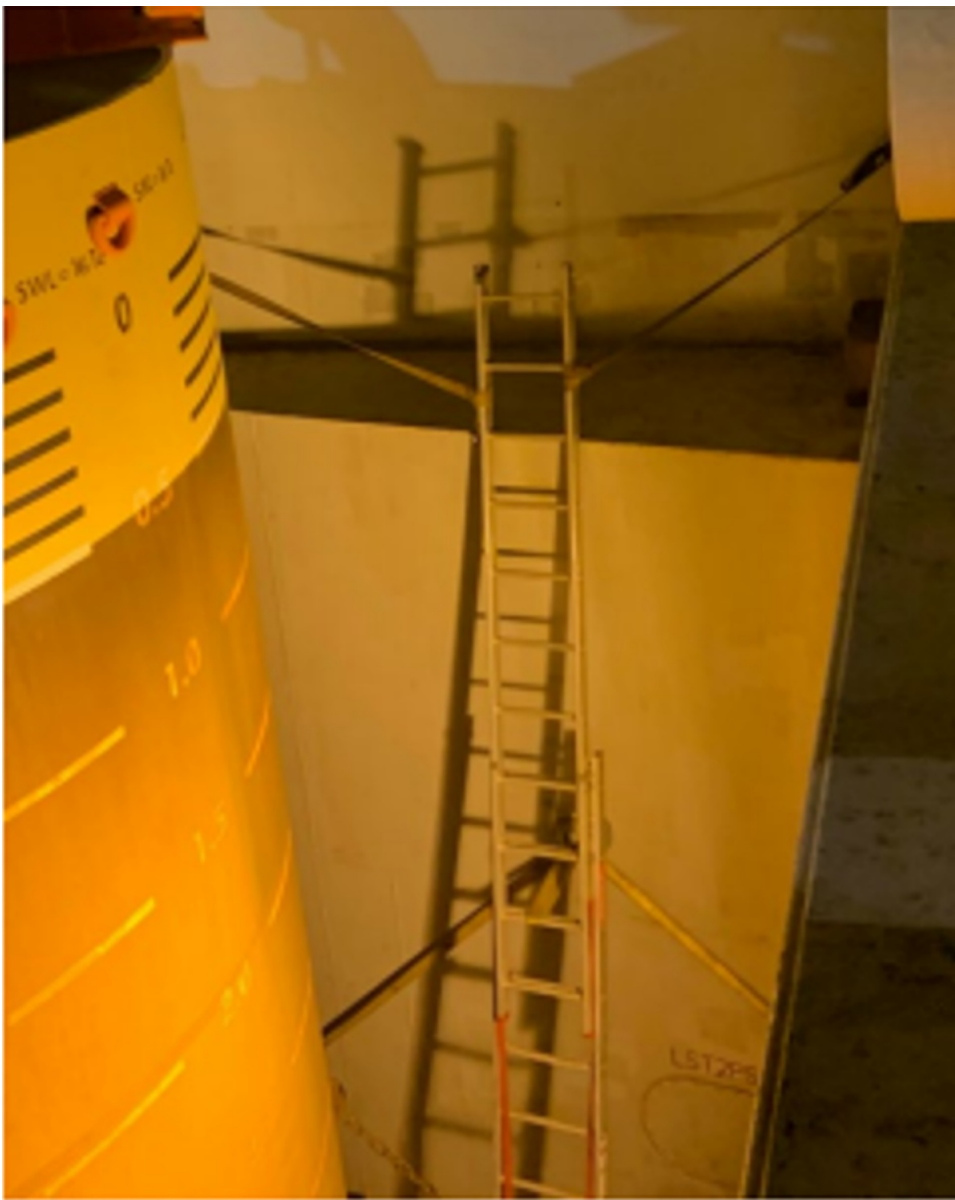
The ladder was installed at a previous equipment mobilisation following realisation that the permanent access / egress hatches to the cargo hold had been blocked. The ladder was secured to a small access platform off the 'tween deck by means of ratchet straps. The platform edge was 5 metres in height with no handrails or fall prevention and the ladder could only be accessed by stepping over the ratchet straps at the exposed edge.

He was alone at this time, it was raining heavily and the equipment and his working attire and PPE were wet. On negotiating the top rungs, he slipped and fell backwards 4 metres to the deck below.

- Use of the ladder was not risk assessed and no working at height / fall protection mitigations were applied. There was no Management of Change applied when the ladder was installed. A work environment was created which influenced crew to use the ladder, creating a “routine violation”.

- Thorough engagement with management of sub-contractor to align HSE expectations:
 - Ensure thorough review of sub-contractor safety arrangements, documents and compliance.
 - Review of the sub-contractor's load plans.
 - Conduct verification activities to ensure a safe working environment and practices prior to starting work (focus on the nine Life Saving Rules and pre-start work checklists).
 - Ensure robust worksite supervision and empower personnel to exercise 'Stop Work Authority'.
- The ladder was removed from the vessel and safe access/egress was implemented.
