NTSB: Fire on vessel – escaped exhaust gases

Safety Flash Published on 14 October 2024 Generated on 22 January 2025 IMCA SF 20/24

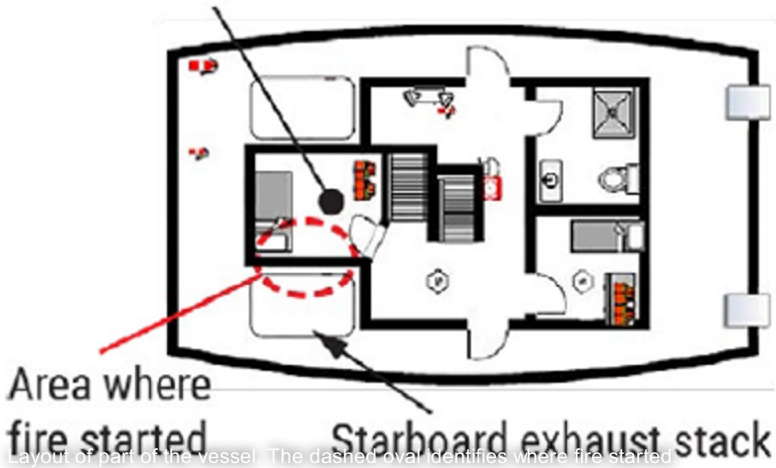
A fire had started behind panels in the pilot's stateroom, which was located between the vessel's two stacks, each containing engine exhaust mufflers and piping. Cracks in the welds on the upper section of the starboard muffler located inside the starboard stack—which may have been caused by a latent issue, such as a defect in the muffler during construction or the exhaust system design's allowance for thermal expansion and contraction of exhaust piping above the muffler outlet—allowed the hot exhaust gases from the operating starboard engine to escape into the stack area and increase the temperature of the space and its bulkheads.

The NTSB's investigation suggested that **undetected cracks** in the starboard muffler allowed exhaust gases from an operating engine to escape and ignite wooden structures affixed to the common bulkhead of an accommodation space. Contributing to the extent of the fire damage was the substantial use of combustible materials in the joinery, outfitting, and furnishings in the accommodation spaces.

Pilot's stateroom

Second deck

- Remember that engine and other machinery exhaust systems generate tremendous amounts of heat. These systems often run through tight spaces that are difficult to access and inspect and are often located near materials or equipment that obstruct entry and direct observation.
- Consider inspection of welding and other potential weak points in such areas.
