ATSB: Undocumented modification contributed to steam burns

Safety Flash Published on 7 November 2025 Generated on 28 January 2026 IMCA SF 20/25

The Australian Transport Safety Bureau (ATSB) has published [Report MO-2025-004](#) into an unplanned pressure release which resulted in burn injuries to three crew members.

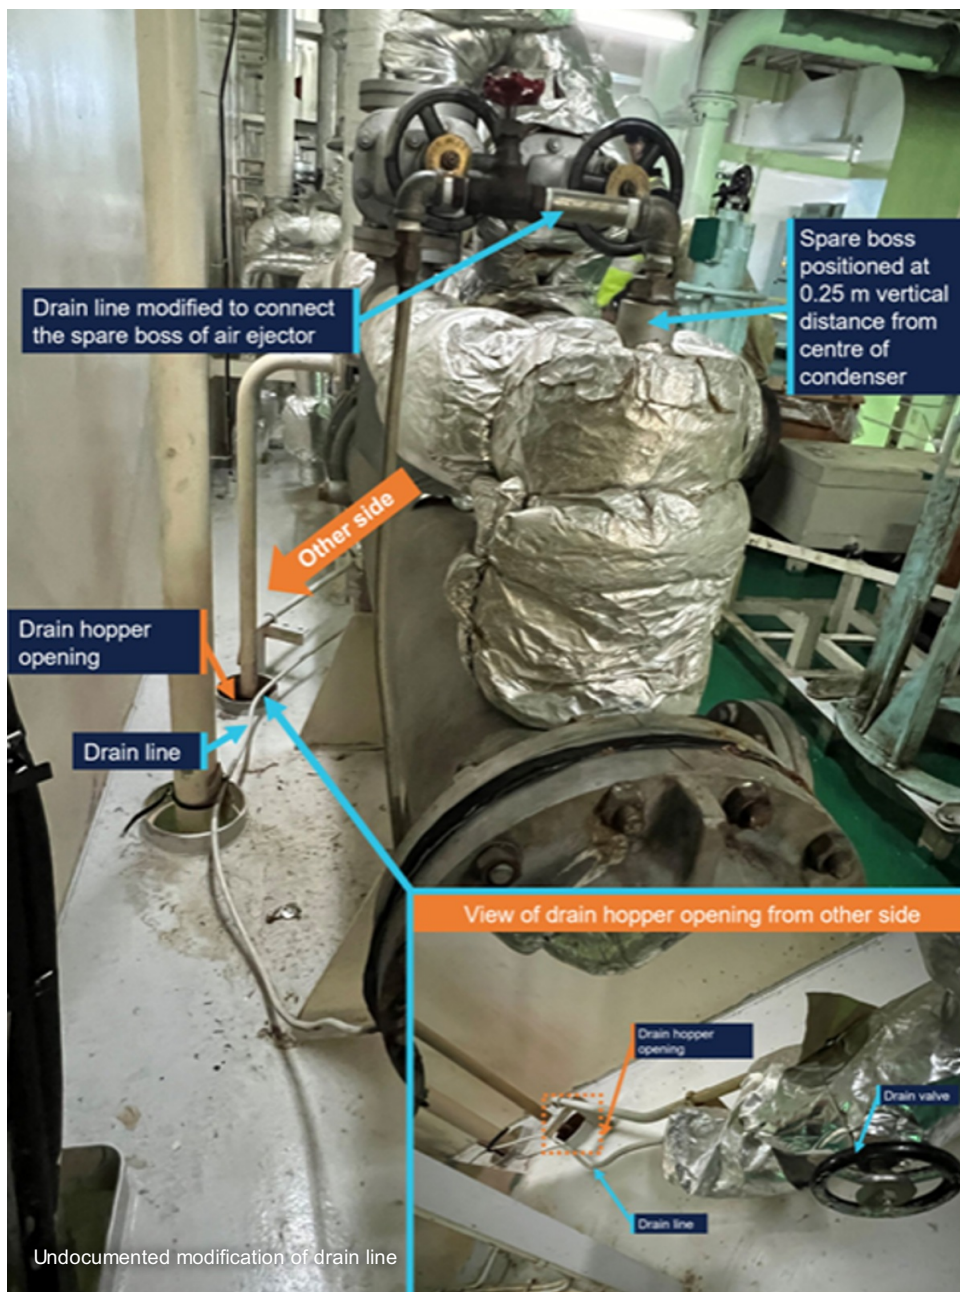
An engineering team was conducting maintenance on the main deck steam valve for the heating system of an oil tanker. After the system was isolated, the team removed the valve bonnet, and residual hot condensate was suddenly released, resulting in burn injuries to three crew members. After receiving first aid on board, the crew members were transported to shore for medical treatment.

- Investigation found the crew had not allowed adequate time for the steam system to cool before starting work on the cargo heating system main deck steam valve.
- The investigation also found a permanent modification to the steam drain line had been implemented on board this vessel without documentation.
 - The ATSB noted that this undocumented change, which was not incorporated into a risk assessment or formally reviewed, likely introduced a system vulnerability that undermined the effectiveness of the steam system isolation.
 - Moreover, the ATSB found the modification was not identified during routine technical inspections or multiple company superintendent visits to the ship.

- Since the incident, the drain line on this vessel was returned to its original

design configuration.

- A fleetwide campaign was started to identify any unauthorised modifications to shipboard piping systems.
- Crew were encouraged to remember that modifications should be undertaken only after appropriate consultation and always in accordance with a formal Management of Change process.
