Dropped object near-miss: Small parts falling from crane rest

Safety Flash Published on 7 December 2015 Generated on 28 January 2026 IMCA SF 21/15

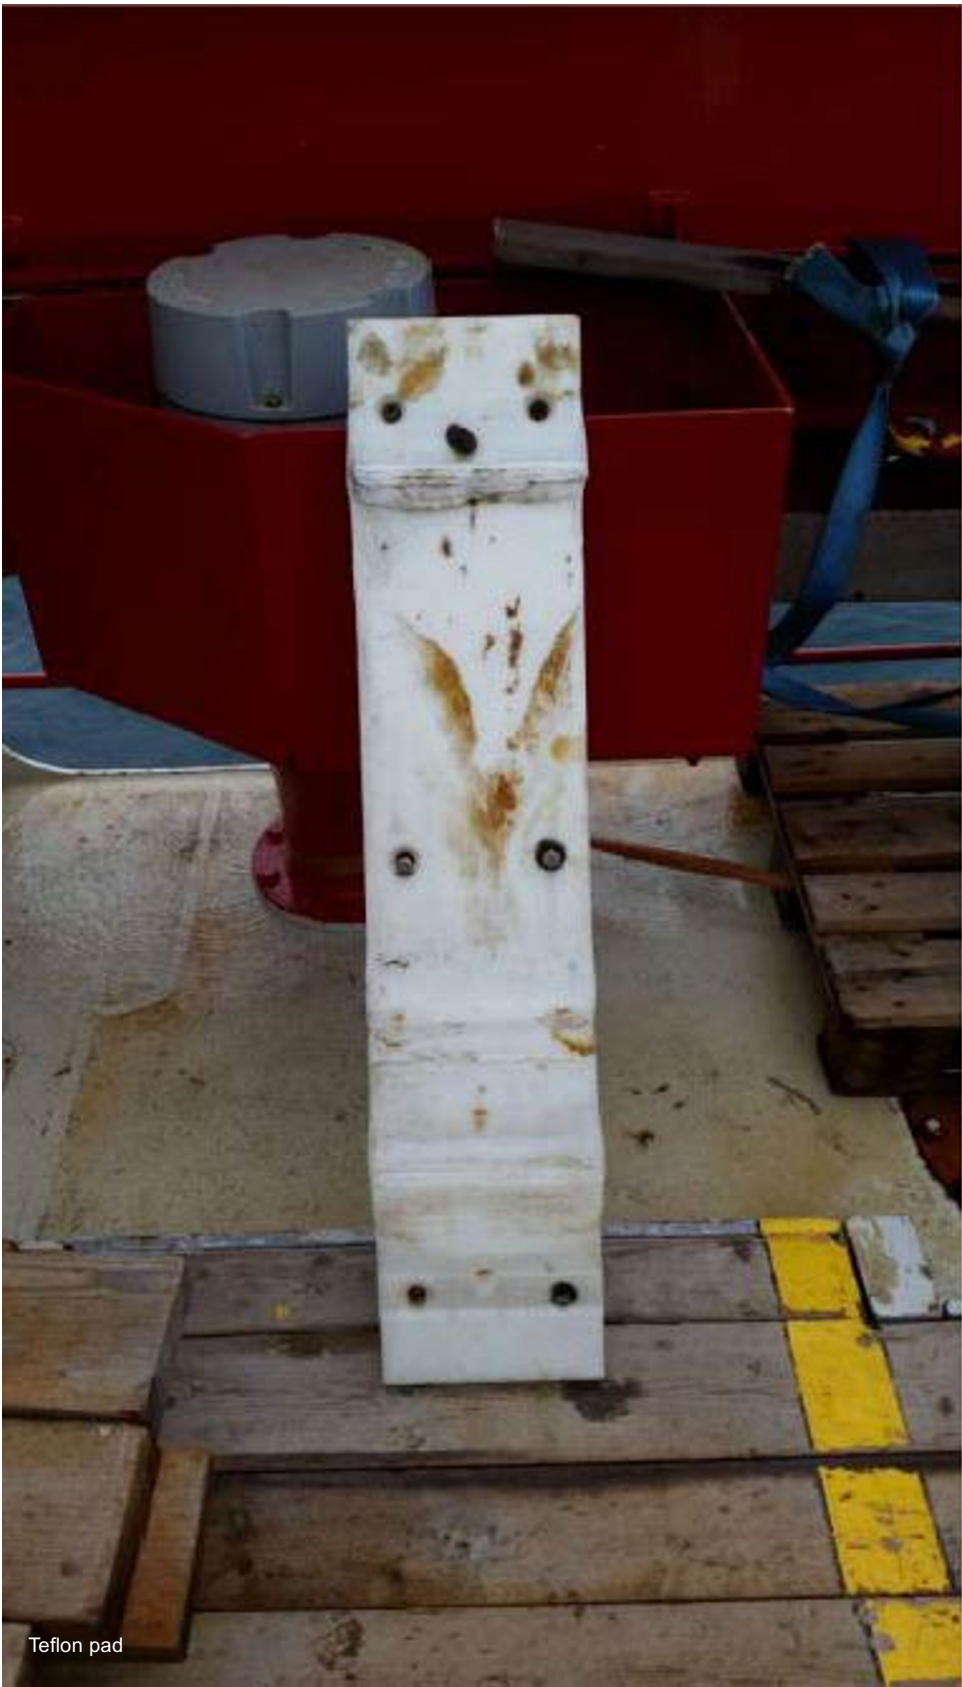
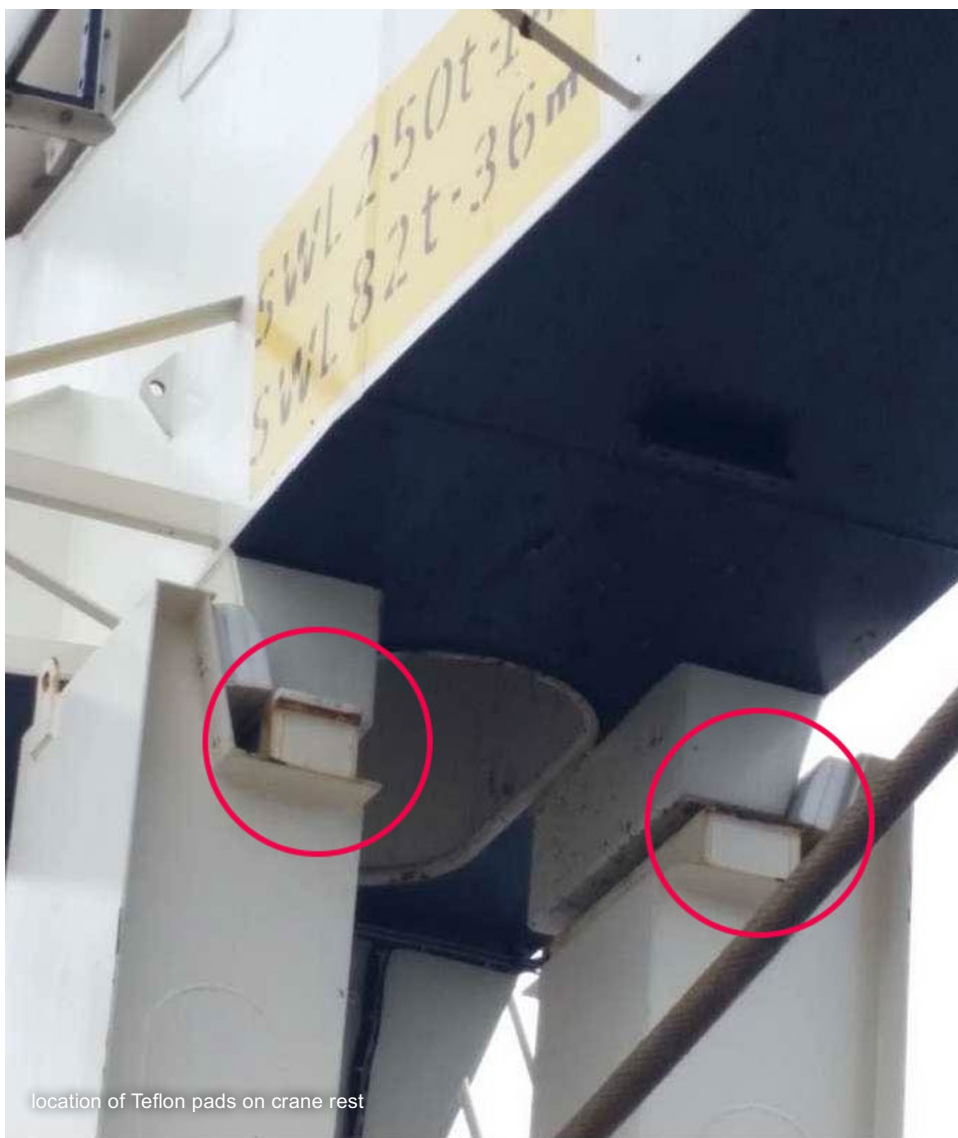
Upon placing the crane boom in the rest, a Teflon pad weighing 6.9 kg, dropped 8.8 metres from the starboard side of the crane rest down to the deck. The pad dropped directly to the deck and landed in an open area, just aft of the crane rest.

- Although at the time the incident was reported to the officer on watch, the company was not informed of the incident until approximately two days later, in which time the crane had been used several times with an identical pad still in situ on the port side of the crane rest.
- Inspection of the dropped pad revealed that sheared parts of only two of six securing bolts remained in the pad.
- A similar incident had occurred on the same vessel some 10 months earlier, where the pad was found to be loose due to sheared retaining bolts.
- This earlier occurrence had not been investigated, allowing a repeat incident to occur with greater consequences.
- The Teflon pads and their retained bolts were inadequately or poorly designed.
- More frequent inspections of crane rest pads should be conducted to identify defects.

Our member concluded that the fundamental design of the pad was flawed. The

purpose of the pad is to buffer impact and movement between the crane and the crane rest to provide protection to the crane boom during parking, stowage and start up. The weakness in the design was demonstrated by the fact that this was the second similar incident to have occurred. Additionally, had the earlier incident been investigated and remedial action taken, this second incident need not have occurred.

- Inspection of the condition of crane rest pads and associated retaining bolts.
- Addition of crane rest pads to planned inspection/maintenance routines.
- Considered the use of secondary retention devices on crane rest pads.
- Reinforced the importance of reporting incidents in a timely manner.
- Ensured deck crews took a 'Time Out for Safety' (TOFS) to reinforce safe crane technique, including the requirement to bank the crane at all times – including parking and releasing the hook/headache ball from its stowage box.

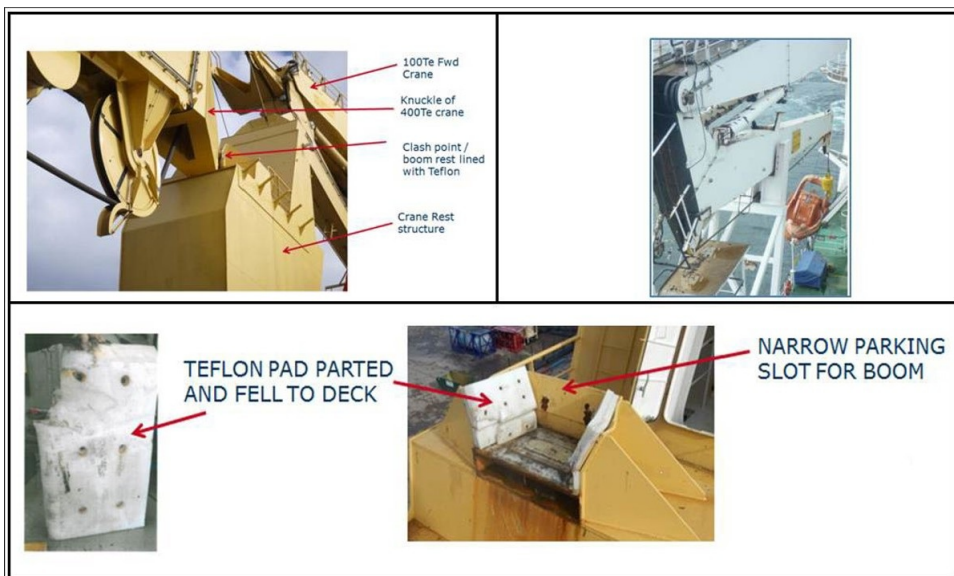
A member reported frequently dropped objects from crane rests during parking and when the crane boom was raised out of the crane rest. The falling objects had been Teflon or wooden landing pads, rubber protection, steel cover plates and nuts/bolts. An example is highlighted below:

- The crane rest had a tight fit/narrow parking slot for the crane boom.
- The crane rest protection cracked and although bolted dislodged as a result of

everyday contact from the crane boom.

- Additionally it was difficult to monitor the landing/raising of the crane boom from the crane cabin.

- Teflon pads have been re-secured using larger washers on the bolts to prevent the bolts from being pulled through the Teflon/rubber, and a secondary chain has been attached to prevent the Teflon/rubber from falling to deck.
- Area around boom rest barriered off before parking/raising the crane boom.
- A dedicated spotter has been used to monitor the crane parking/raising operation.
- Cameras installed to aid inspection of the crane boom rest and assist parking/raising.
