## Fatality during loading operations

Safety Flash Published on 7 December 2015 Generated on 21 January 2025 IMCA SF 21/15

**A Member has reported an incident in which a crew member was struck and fatally injured by a mini-container whilst working on back-loaded cargo from a drilling rig.**

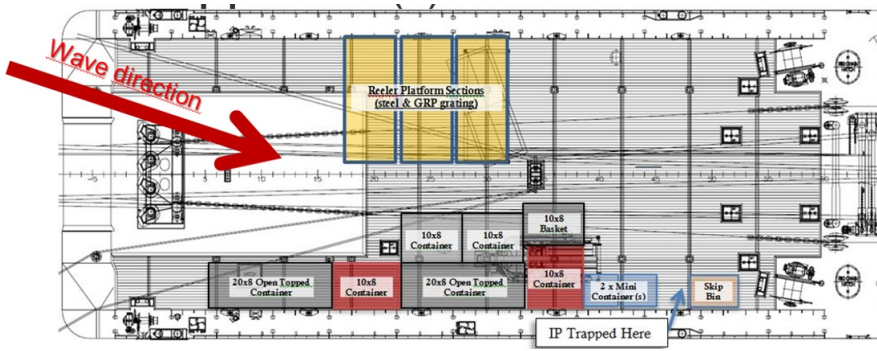
During this time the deck crew continued work on securing the cargo. Two Able Seamen (ABs) working on the deck decided that the sea fastening arrangement was not adequate to restrain the two mini containers located at the forward end of the deck. Additional rigging was required to rectify this, and one of the ABs left the deck to go to the nearby rigging store. The tension on the tugger winch was released to facilitate installation of the new rigging. A large wave crashed over the back deck of the vessel and travelled along the length of the deck, with the force of the wave causing movement of some of the landed cargo. The movement of this cargo resulted in the ABs becoming trapped between a mini container and a skip bin, with fatal consequences.

plan view of vessel

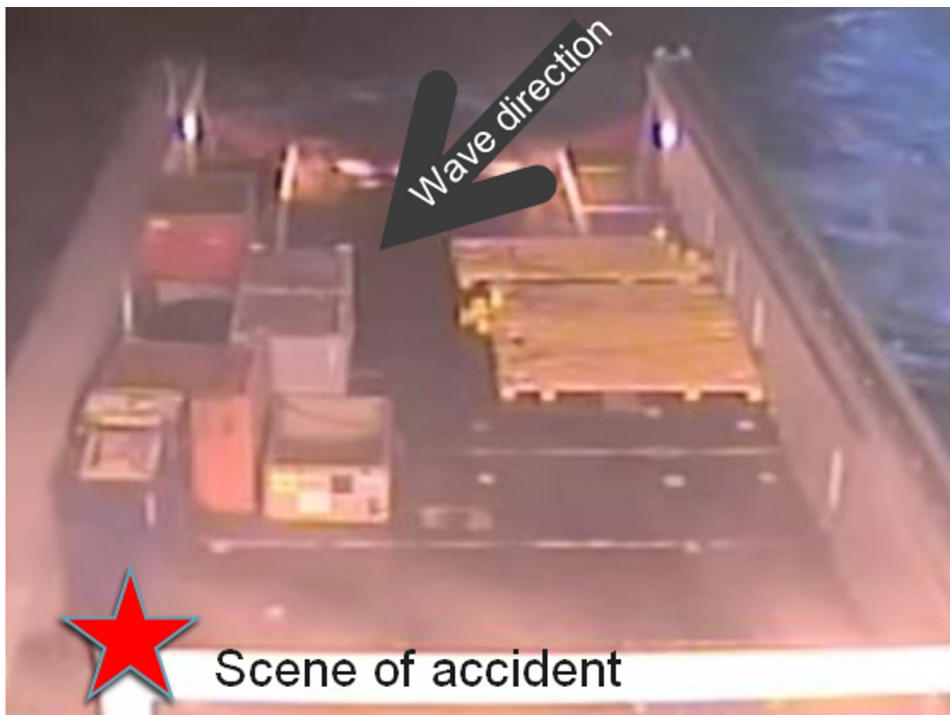
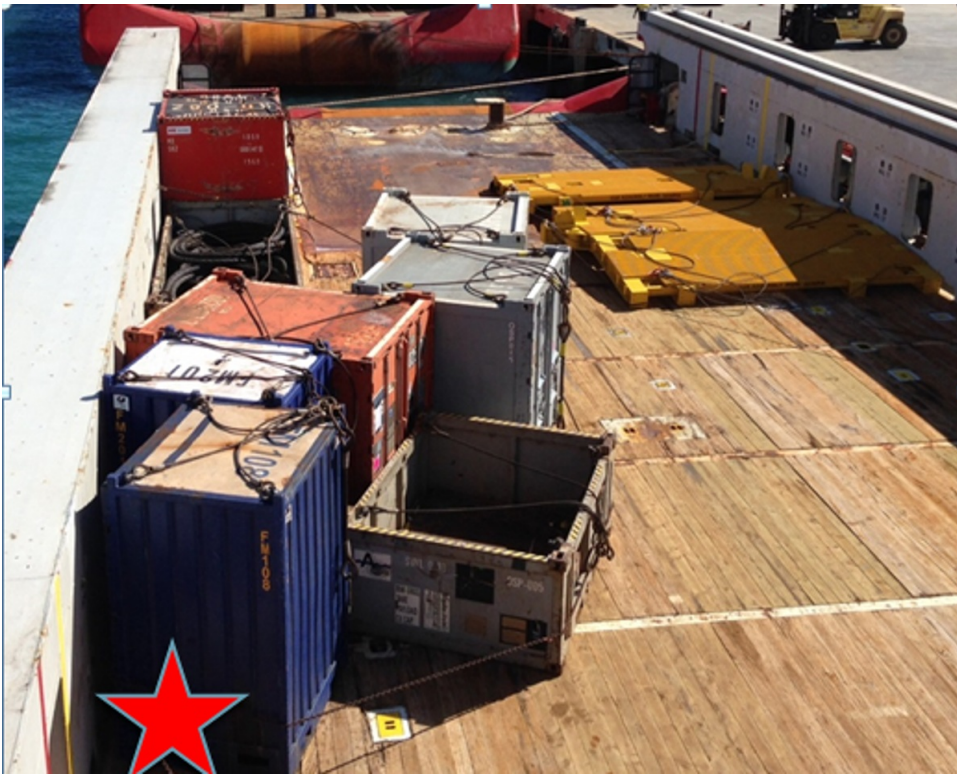
photograph showing scene of incident

- Working in and around unsecured cargo had become part of a familiar routine.
- A vessel with an open stern being used for cargo operations.
- Wave struck cargo.
- Cargo shifted 3-4 m on deck aft to forward.
- The crewman involved did not get out of the 'line of fire' or hear the bridge warning over UHF radio.

- Vessel operations in the 500m rig zone are not recognised as Simultaneous Operations (SIMOPS) for the rig and vessel. There was no process in place to ensure effective communications, load sequencing, deck layout planning, cargo securing plans and optimising time of vessel alongside rig in Dynamic Positioning (DP) mode.
- The potential for injuries to crew undertaking cargo securing tasks offshore on Anchor Handling Tug Supply (AHTS) vessels (due to open stern) had not been identified as high risk.
- No risk assessment had been carried out for suitability of AHTS vessels performing cargo operations.

- The vessel procedure for cargo loading and unloading did not describe a cargo lashing plan, and although there was a risk assessment for cargo loading, there was no specific risk assessment for the work activities associated with the further securing of landed cargo.

- Further detailed risk assessment for AHTS conducting cargo operations. Risk assessment should include consideration of engineering controls to minimise excessive water on the vessel back deck (stern door or use of other vessel type).
- A review and update of company adverse weather working guidelines.
- A review of company cargo loading procedure to include cargo lashing arrangements, and further risk assessment for securing cargo.
- A review and update of company cargo securing procedure and risk assessment to include the requirement for a lashing plan and load sequence planning with rig before entering the 500m zone.
