High potential near-miss: SWL plate fell from crane auxiliary block

Safety Flash Published on 7 December 2015 Generated on 28 January 2026 IMCA SF 21/15

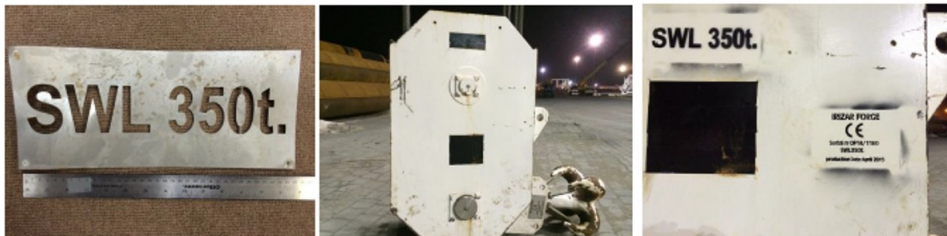
The incident occurred when a crane fast line was being used for loading operations from the quayside. A banksman and two riggers were on the quay in the process of choking off the lifting slings and connecting them to the crane fast line hook. During this task a steel SWL plate (0.7 kg) fell from the Crane Auxiliary Block which was not being used at that time.

The SWL plate fell from approximately 71 m in height and landed at approximately 5 m away from the working party. The DROPS calculator tells us that such an object falling from such a height could have caused a fatality had it hit someone.

- The SWL plate fell from the crane auxiliary block and there were similar plates still on this block and on the main block. Both these blocks, and the whip line block, had all been replaced during the re-fit period to enable the crane to operate subsea for a particular project.
- The means of securing the plates was of poor design – several plates including the one dropped were attached by four rivets of dissimilar metals (aluminium vs steel) promoting galvanic corrosion process and salt water corrosion.
- All plates showed signs of corrosion behind the plate – however deterioration of the rivets was not visible on the plate surface.
- All plates were flush against their fixings and looked secure to any visual

inspection.

- The plates were removed.
- SWL and other identifying information was stencilled on the crane instead.
- There was an inspection of similar hook blocks elsewhere to verify that there were no loose objects or unsecured plates.
- The crane supplier/manufacture was informed of the incident (lessons learnt to prevent further reoccurrence).
